Access Compliance Report

Public Rights-of-Way

(Curb Ramps)

| Intersection ID: 52790 | Main Street: COLEMON_KERRY_DR | Cross Street: FRIENDSHIP_VILLAGE_PL | Location: NE |

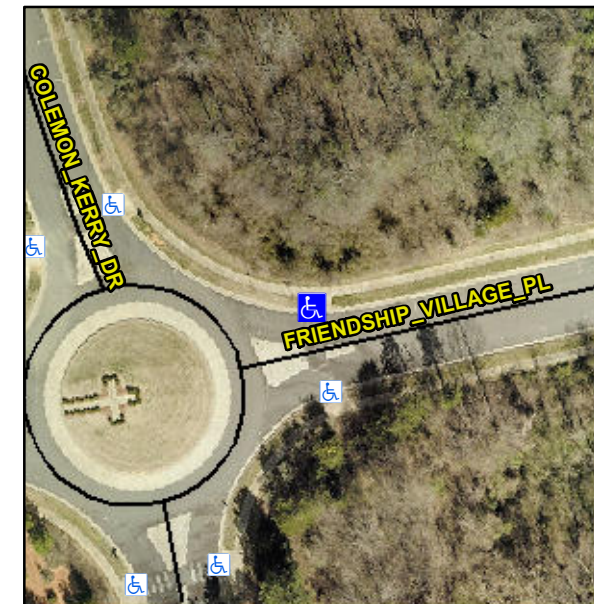
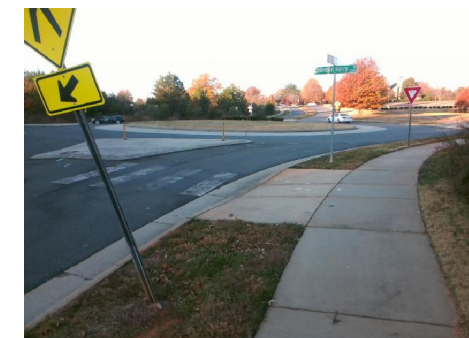
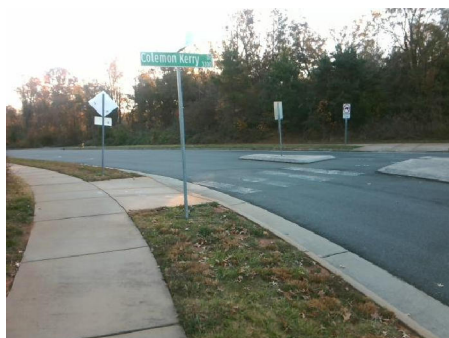
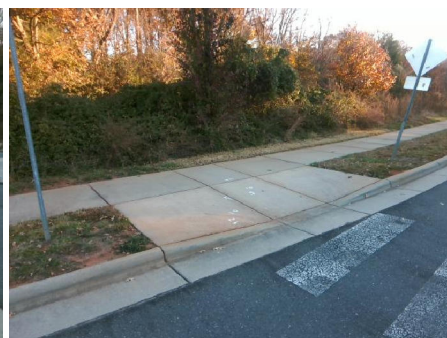
Not Found, R304.5.1, R304.2.2

| Compliance | Description | Data | Compliance | Description | Data |
|---|---|---|---|---|---|
| N/A | Ramp Length (in) | 72.0 | No | Ramp Slope (%) | 8.9 |
| No | Ramp Width (in) | 45.0 | Yes | Ramp XSlope (%) | 1.0 |

Remove & Replace Entire Ramp.
