Access Compliance Report

Public Rights-of-Way

(Curb Ramps)

Intersection ID: 18423	Main Street: ELESSAR_PL	Cross Street: STRIDER_DR	Location: E
ADA ID: 5CBCD3C40BB2	Ramp Type: BlendTrans1	Initial Pass/Fail: Fail	Overall Compliance: No
		Severity Score: 10

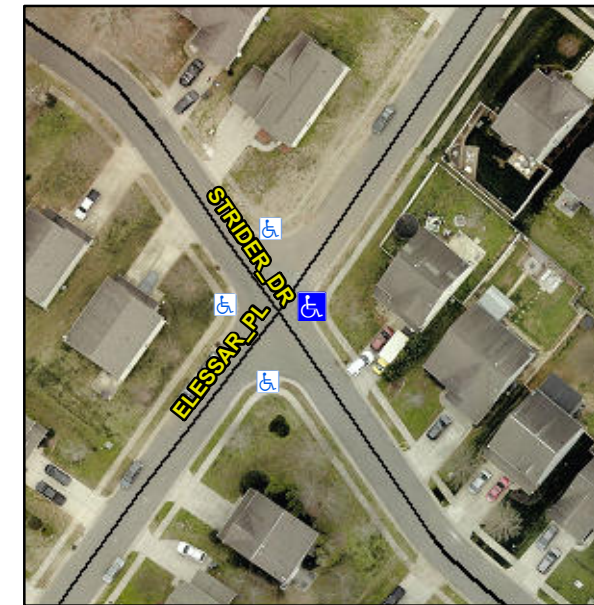
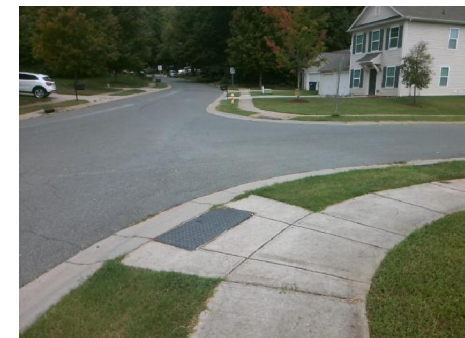
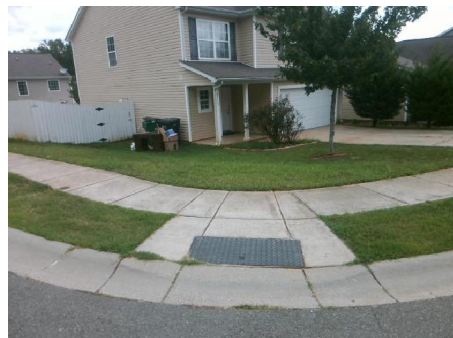
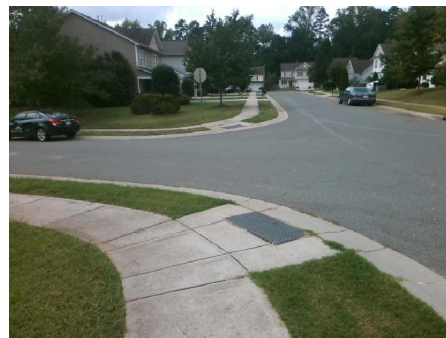
Not Found, R304.5.1, R304.5.3

Compliance	Description	Data	Compliance	Description	Data
N/A	Ramp Length (in)	49.0	Yes	BlendTrans Slope (%)	3.6
No	Ramp Width (in)	38.0	No	BlendTrans XSlope (%)	3.5
N/A	Flare Type LT	N/A	N/A	Flare Type RT	N/A
N/A	Flare Slope LT (%)	N/A	N/A	Flare Slope RT (%)	N/A
N/A	Flare Traversable LT?	N/A	N/A	Flare Traversable RT?	N/A
N/A	Landing Length (in)	N/A	N/A	DWS Provided?	N/A
N/A	Landing Width (in)	N/A	N/A	DWS Contrast?	N/A
N/A	Landing Slope (%)	N/A	N/A	DWS Length (in)	N/A
N/A	Landing X Slope (%)	N/A	N/A	DWS Full Width?	N/A
N/A	Landing Curb? (Y/N)	N/A	N/A	DWS Offset (in)	N/A
N/A	Shared Landing?	N/A			
N/A	Gutter Ponding?	N/A	N/A	Gutter Slope (%)	N/A
N/A	Gutter Lip Ht (in)	N/A	N/A	Gutter X Slope (%)	N/A
N/A	Painted X Walk1?	No	N/A	Painted X Walk2?	No
	X Walk 1 Direction	To NW		X Walk 2 Direction	To SW
	X Walk 1 Width (in)	N/A		X Walk 2 Width (in)	N/A
	X Walk 1 Slope (%)	1.2		X Walk 2 Slope (%)	2.5
	X Walk 1 X Slope (%)	2.3		X Walk 2 X Slope (%)	3.1

N/A	Ramp inside XWalk1?	N/A	N/A	Ramp inside XWalk2?	N/A
	Road Slope (%)	1.1		Clear Space?	N/A
	Road X Slope (%)	4.8	N/A	Clear Space to XWalk (in)	N/A
N/A	Any Obstructions?	N/A	N/A	Storm Grate/Utility Hazard?	N/A
	Obstruction Type			Storm Grate/Utility Type	
		N/A			N/A
			Yes	Surface Condition? (G/P)	Good
			No	Curb Slope (%)	8.2

Remove & Replace Curb Ramp With Two New Directional Ramps or Equivalent.
