Access Compliance Report

Public Rights-of-Way

(Curb Ramps)

Intersection ID: 53624	Main Street: PROSPERITY RIDGE RD	Cross Street: RIDGE RD	Location: NW
ADA ID: 5CDBF5A09B07	Ramp Type: Directional1	Initial Pass/Fail: Fail	Overall Compliance: No
Severity Score: 13.75			
Codes/Mitigation Info/Possible Solution		Field Measurements/Component Compliance

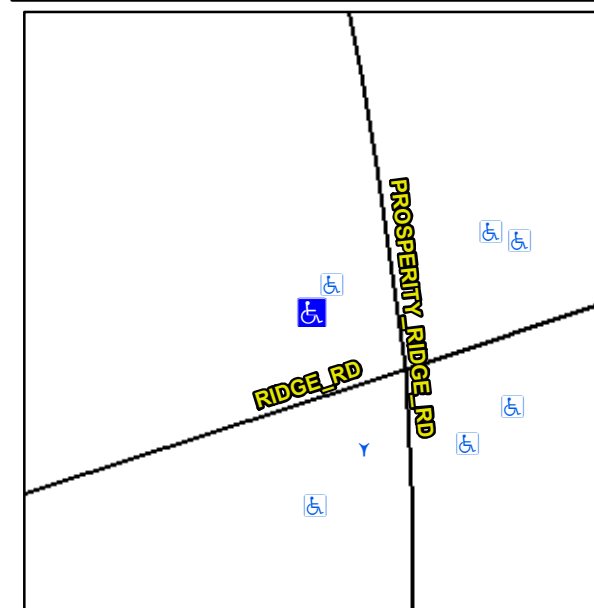
Compliance	Description	Data	Compliance	Description	Data
N/A	Ramp Length (in)	109.0	N/A	Grade Break?	N/A
Yes	Ramp Width (in)	60.0	N/A	Grade Break Slope (%)	0.0
No	Ramp Slope (%)	9.4	N/A	Grade Break XSlope (%)	0.0
Yes	Ramp XSlope (%)	2.7			
N/A	Flare Type LT	N/A	N/A	Flare Type RT	N/A
N/A	Flare Slope LT (%)	N/A	N/A	Flare Slope RT (%)	0.0
N/A	Flare Traversable LT?	N/A	N/A	Flare Traversable RT?	N/A
N/A	Landing Length (in)	0.0	N/A	DWS Provided?	N/A
N/A	Landing Width (in)	0.0	N/A	DWS Contrast?	N/A
N/A	Landing Slope (%)	0.0	N/A	DWS Length (in)	N/A
N/A	Landing X Slope (%)	0.0	N/A	DWS Full Width?	N/A
N/A	Landing Curb? (Y/N)	N/A	N/A	DWS Offset LT (in)	N/A
N/A	Shared Landing?	N/A	N/A	DWS Offset RT (in)	N/A
N/A	Gutter Ponding?	0.0	N/A	Gutter Slope (%)	N/A
N/A	Gutter Lip Ht (in)	0.0	N/A	Gutter X Slope (%)	N/A
N/A	Painted X Walk1?	Yes		Road Slope (%)	3.6
	X Walk 1 Direction	To S		Road X Slope (%)	3.0
	X Walk 1 Width (in)	112.5		Clear Space?	N/A

X Walk 1 Slope (%)	3.6	N/A	Clear Space to XWalk (in)	N/A
	X Walk 1 X Slope (%)	3.0	N/A	Storm Grate/Utility Hazard?	N/A
N/A	Ramp inside XWalk1?	Yes		Storm Grate/Utility Type	
N/A	Any Obstructions?	N/A			N/A
	Obstruction Type		Yes	Surface Condition? (G/P)	Good
			N/A	Curb Slope (%)	N/A

Possible Solutions:

Remove & Replace Entire Ramp.

R304.2.2

\$ 1600.00
