Intersection ID: 10038783	Main Street: STEELE_CREEK_RD	Cross Street: N/A	Location:	SE
ADA ID: 5CE5C0983A67	Ramp Type: Perp	Initial Pass/Fail: Fail	Overall Compliance: No	Severity Score: 12.5

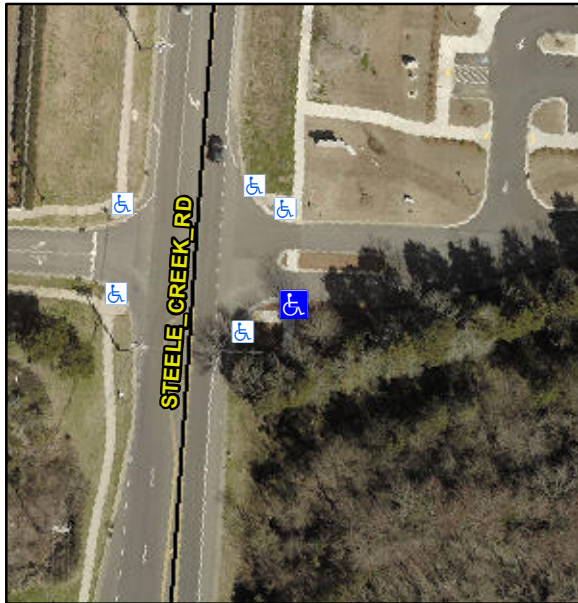
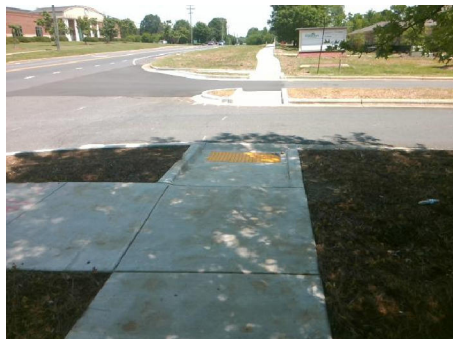
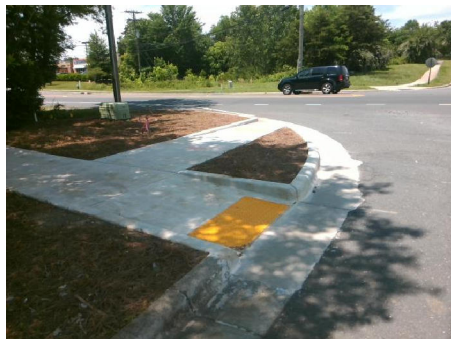
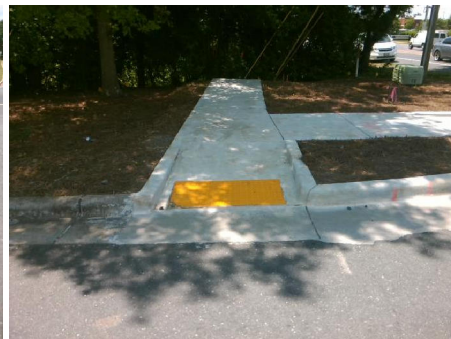
Possible Solutions:			Compliance	Description	Data	Compliance	Description	Data
Remove & Replace Entire Ramp.	N/A	Ramp Length (in)	74.0	No	Ramp Slope (%)	8.8		
	Yes	Ramp Width (in)	58.0	Yes	Ramp XSlope (%)	0.8		
	N/A	Flare Type LT	N/A	N/A	Flare Type RT	N/A		
	N/A	Flare Slope LT (%)	N/A	N/A	Flare Slope RT (%)	N/A		
	N/A	Flare Traversable LT?	N/A	N/A	Flare Traversable RT?	N/A		
	N/A	Landing Length (in)	N/A	N/A	DWS Provided?	N/A		
	N/A	Landing Width (in)	N/A	N/A	DWS Contrast?	N/A		
	N/A	Landing Slope (%)	N/A	N/A	DWS Length (in)	N/A		
	N/A	Landing X Slope (%)	N/A	N/A	DWS Full Width?	N/A		
	N/A	Landing Curb? (Y/N)	N/A	N/A	DWS Offset (in)	N/A		
Surveyor Notes: N/A	N/A	Shared Landing?	N/A					
	N/A	Gutter Ponding?	N/A	N/A	Gutter Slope (%)	N/A		
	N/A	Gutter Lip Ht (in)	N/A	N/A	Gutter X Slope (%)	N/A		
	N/A	Painted X Walk1?	No	N/A	Painted X Walk2?	N/A		
		X Walk 1 Direction	To N		X Walk 2 Direction	N/A		
	N/A	X Walk 1 Width (in)	N/A	N/A	X Walk 2 Width (in)	N/A

X Walk 1 Slope (%)	1.7		X Walk 2 Slope (%)	N/A		
		X Walk 1 X Slope (%)	2.6		X Walk 2 X Slope (%)	N/A		
	N/A	Ramp inside XWalk1?	N/A	N/A	Ramp inside XWalk2?	N/A		
		Road Slope (%)	N/A	N/A	Clear Space?	N/A		
PROW/ADA: R304.2.2		Road X Slope (%)	N/A	N/A	Clear Space to XWalk (in)	N/A		
	N/A	Any Obstructions?	N/A	N/A	Storm Grate/Utility Hazard?	N/A		
		Obstruction Type			Storm Grate/Utility Type			
			N/A			N/A		
				Yes	Surface Condition? (G/P)	Good		
	Total Cost:	\$	1850.00

Possible Solutions:

Remove & Replace Entire Ramp.

R304.2.2
