Access Compliance Report

Public Rights-of-Way

(Curb Ramps)

Intersection ID: 10199	Main Street: CALTON_LN	Cross Street: TUCKASEEGEE_RD	Location: E
ADA ID: 5CE6AAF635ED	Ramp Type: Perp	Initial Pass/Fail: Fail	Overall Compliance: No
		Severity Score: 22.5

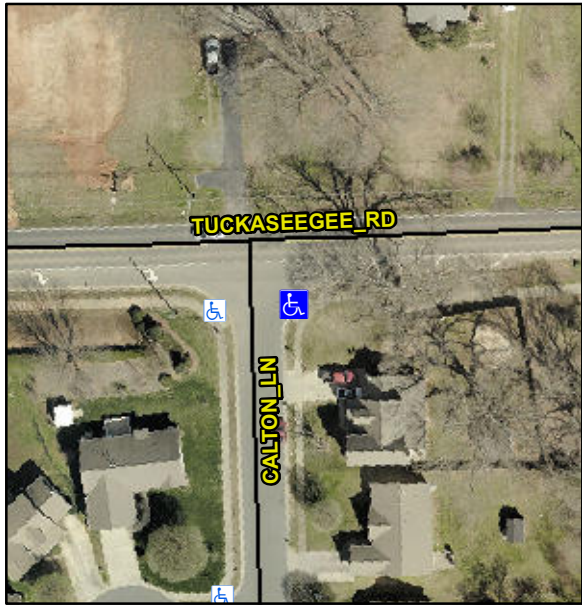
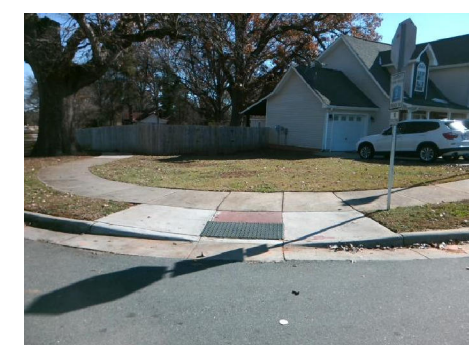
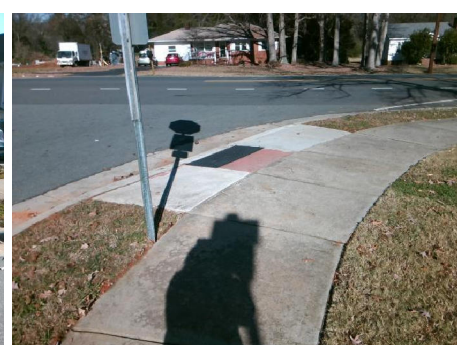
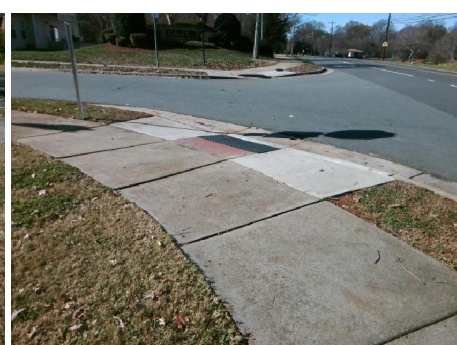
Possible Solutions:		Compliance	Description	Data	Compliance	Description	Data
	Remove & Replace Entire Ramp.		N/A	Ramp Length (in)	48.0	No	Ramp Slope (%)	9.3
			No	Ramp Width (in)	45.0	No	Ramp XSlope (%)	2.1
			N/A	Flare Type LT	N/A	N/A	Flare Type RT	N/A
			N/A	Flare Slope LT (%)	N/A	N/A	Flare Slope RT (%)	N/A
			N/A	Flare Traversable LT?	N/A	N/A	Flare Traversable RT?	N/A
			N/A	Landing Length (in)	N/A	N/A	DWS Provided?	N/A
			N/A	Landing Width (in)	N/A	N/A	DWS Contrast?	N/A
			N/A	Landing Slope (%)	N/A	N/A	DWS Length (in)	N/A
			N/A	Landing X Slope (%)	N/A	N/A	DWS Full Width?	N/A
Surveyor Notes:		N/A	N/A	Landing Curb? (Y/N)	N/A	N/A	DWS Offset (in)	N/A
PROW/ADA:		Not Found, R304.5.1, R304.2.2, R304.5.3	N/A	Shared Landing?	N/A	N/A	Gutter Slope (%)	N/A
			N/A	Gutter Ponding?	N/A	N/A	Gutter X Slope (%)	N/A
			N/A	Gutter Lip Ht (in)	0.5	N/A	Painted X Walk2?	N/A

N/A	Painted X Walk1?	No	N/A	X Walk 2 Direction	N/A
				X Walk 1 Direction	To W		X Walk 2 Width (in)	N/A
			N/A	X Walk 1 Width (in)	N/A	N/A	X Walk 2 Slope (%)	N/A
				X Walk 1 Slope (%)	3.0		X Walk 2 X Slope (%)	N/A
				X Walk 1 X Slope (%)	1.6		Ramp inside XWalk2?	N/A
			N/A	Ramp inside XWalk1?	N/A	N/A	Clear Space?	N/A
				Road Slope (%)	N/A	N/A	Clear Space to XWalk (in)	N/A
				Road X Slope (%)	N/A	N/A	Storm Grate/Utility Hazard?	N/A
			N/A	Any Obstructions?	N/A	N/A	Storm Grate/Utility Type	
				Obstruction Type				
					N/A			N/A
						Yes	Surface Condition? (G/P)	Good
Street 1 Name		CALTON LN						
Stop Condition-Street 2		StopSign						
Street 2 Name		N/A						
Stop Condition-Street 1		N/A						
Total Cost:		\$ 1850.00
