Access Compliance Report Public Rights-of-Way (Curb Ramps)

Intersection ID: 48956 Main Street: JOSHUA_CAIN_RD Cross Street: DAVID_JENNINGS_AV Location: N

ADA ID: 5CE6B4AA938D Ramp Type: Perp Initial Pass/Fail: Fail Overall Compliance: No Severity Score: 8.75

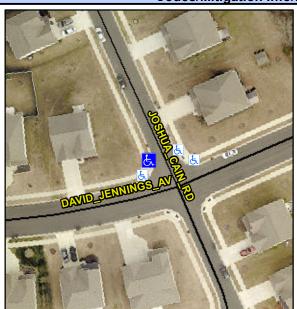
Yes N/A Ramp Length (in) 67.0 Ramp Slope (%) 6.8 Yes Ramp XSlope (%) No Ramp Width (in) 47.5 1.5 N/A N/A Flare Type LT N/A Flare Type RT N/A N/A N/A N/A Flare Slope RT (%) N/A Flare Slope LT (%) N/A Flare Traversable LT? N/A N/A Flare Traversable RT? N/A N/A N/A N/A **DWS Provided?** N/A Landing Length (in) N/A Landing Width (in) N/A N/A **DWS Contrast?** N/A N/A N/A N/A Landing Slope (%) DWS Length (in) N/A N/A Landing X Slope (%) N/A N/A DWS Full Width? N/A Landing Curb? (Y/N) N/A N/A DWS Offset (in) N/A N/A Shared Landing? **Gutter Ponding?** N/A N/A Gutter Slope (%) N/A Gutter Lip Ht (in) 1.0 N/A Gutter X Slope (%) N/A Painted X Walk1? No N/A Painted X Walk2? N/A X Walk 1 Direction To E X Walk 2 Direction N/A N/A X Walk 1 Width (in) N/A X Walk 2 Width (in) N/A X Walk 1 Slope (%) 3.7 X Walk 2 Slope (%) N/A X Walk 1 X Slope (%) 0.3 X Walk 2 X Slope (%) N/A N/A N/A Ramp inside XWalk2? Ramp inside XWalk1? N/A Road Slope (%) N/A N/A Clear Space? N/A N/A Road X Slope (%) N/A Clear Space to XWalk (in) N/A N/A Any Obstructions? N/A Storm Grate/Utility Hazard? N/A **Obstruction Type** Storm Grate/Utility Type N/A N/A Yes Surface Condition? (G/P) Good

Possible Solutions:

Remove & Replace Entire Ramp.
