# Access Compliance Report

## Public Rights-of-Way

### (Curb Ramps)

Intersection ID: 28353	Main Street: HIRSCH_DR	Cross Street: LINDAHI_LN	Location:	NE
ADA ID: 5CEECEB5A36C7	Ramp Type: Perp	Initial Pass/Fail: Fail	Overall Compliance: No	Severity Score: 10
Codes/Mitigation Info/Possible Solution		Field Measurements/Component Compliance

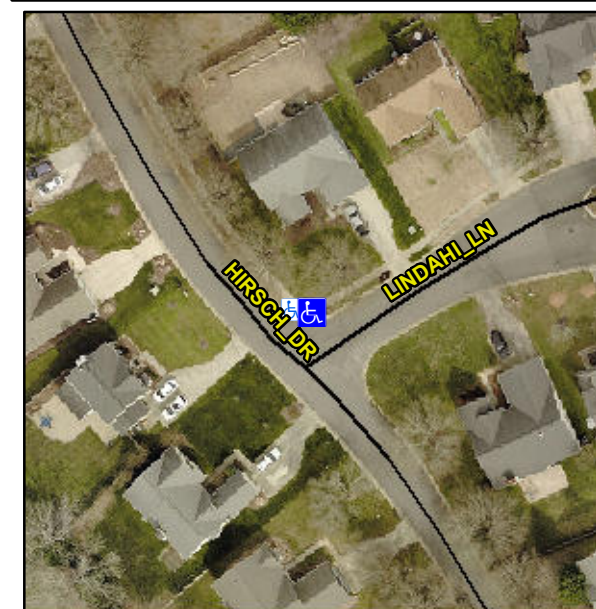
**Not Found, R304.5.1, R304.5.3**

Compliance	Description	Data	Compliance	Description	Data
N/A	Ramp Length (in)	57.0	Yes	Ramp Slope (%)	5.6
No	Ramp Width (in)	46.5	No	Ramp XSlope (%)	2.2
N/A	Flare Type LT	N/A	N/A	Flare Type RT	N/A
N/A	Flare Slope LT (%)	N/A	N/A	Flare Slope RT (%)	N/A
N/A	Flare Traversable LT?	N/A	N/A	Flare Traversable RT?	N/A
N/A	Landing Length (in)	N/A	N/A	DWS Provided?	N/A
N/A	Landing Width (in)	N/A	N/A	DWS Contrast?	N/A
N/A	Landing Slope (%)	N/A	N/A	DWS Length (in)	N/A
N/A	Landing X Slope (%)	N/A	N/A	DWS Full Width?	N/A
N/A	Landing Curb? (Y/N)	N/A	N/A	DWS Offset (in)	N/A
N/A	Shared Landing?	N/A			
N/A	Gutter Ponding?	N/A	N/A	Gutter Slope (%)	N/A
N/A	Gutter Lip Ht (in)	N/A	N/A	Gutter X Slope (%)	N/A
N/A	Painted X Walk1?	No	N/A	Painted X Walk2?	N/A
	X Walk 1 Direction	To SE		X Walk 2 Direction	N/A
N/A	X Walk 1 Width (in)	N/A	N/A	X Walk 2 Width (in)	N/A
	X Walk 1 Slope (%)	1.3		X Walk 2 Slope (%)	N/A
	X Walk 1 X Slope (%)	0.2		X Walk 2 X Slope (%)	N/A

N/A	Ramp inside XWalk1?	N/A	N/A	Ramp inside XWalk2?	N/A
	Road Slope (%)	N/A	N/A	Clear Space?	N/A
	Road X Slope (%)	N/A	N/A	Clear Space to XWalk (in)	N/A
N/A	Any Obstructions?	N/A	N/A	Storm Grate/Utility Hazard?	N/A
	Obstruction Type			Storm Grate/Utility Type	
		N/A			N/A
			Yes	Surface Condition? (G/P)	Good

**Remove & Replace Entire Ramp.**

Total Cost: \$ 1850.00
