Access Compliance Report

Public Rights-of-Way

(Curb Ramps)

Intersection ID: 45541	Main Street: PEACHTREE_RD	Cross Street: HARRIER_RD	Location: SE
ADA ID: 5CEEED726C7F	Ramp Type: PerpDiag	Initial Pass/Fail: Fail	Overall Compliance: No
Severity Score: 10			
Codes/Mitigation Info/Possible Solution		Field Measurements/Component Compliance

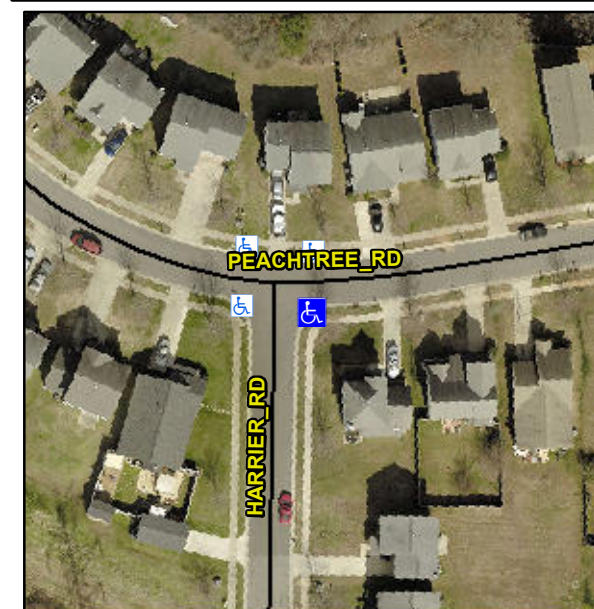
Compliance	Description	Data	Compliance	Description	Data
N/A	Ramp Length (in)	47.0	Yes	Ramp Slope (%)	5.6
No	Ramp Width (in)	46.0	No	Ramp XSlope (%)	2.9
N/A	Flare Type LT	N/A	N/A	Flare Type RT	N/A
N/A	Flare Slope LT (%)	N/A	N/A	Flare Slope RT (%)	N/A
N/A	Flare Traversable LT?	N/A	N/A	Flare Traversable RT?	N/A
N/A	Landing Length (in)	N/A	N/A	DWS Provided?	N/A
N/A	Landing Width (in)	N/A	N/A	DWS Contrast?	N/A
N/A	Landing Slope (%)	N/A	N/A	DWS Length (in)	N/A
N/A	Landing X Slope (%)	N/A	N/A	DWS Full Width?	N/A
N/A	Landing Curb? (Y/N)	N/A	N/A	DWS Offset (in)	N/A
N/A	Shared Landing?	N/A			
N/A	Gutter Ponding?	N/A	N/A	Gutter Slope (%)	N/A
N/A	Gutter Lip Ht (in)	N/A	N/A	Gutter X Slope (%)	N/A
N/A	Painted X Walk1?	No	N/A	Painted X Walk2?	No
	X Walk 1 Direction	To N		X Walk 2 Direction	To W
N/A	X Walk 1 Width (in)	N/A	N/A	X Walk 2 Width (in)	N/A
	X Walk 1 Slope (%)	1.2		X Walk 2 Slope (%)	0.5
	X Walk 1 X Slope (%)	0.1		X Walk 2 X Slope (%)	1.5

N/A	Ramp inside XWalk1?	N/A	N/A	Ramp inside XWalk2?	N/A
	Road Slope (%)	1.6	N/A	Clear Space?	N/A
	Road X Slope (%)	0.0	N/A	Clear Space to XWalk (in)	N/A
N/A	Any Obstructions?	N/A	N/A	Storm Grate/Utility Hazard?	N/A
	Obstruction Type			Storm Grate/Utility Type	
		N/A			N/A
		Yes		Surface Condition? (G/P)	Good

Remove & Replace Curb Ramp With Two New Directional Ramps or Equivalent.

R304.5.1, R304.5.3

Total Cost: \$ 3200.00

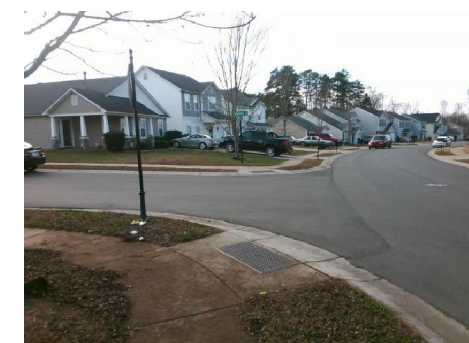
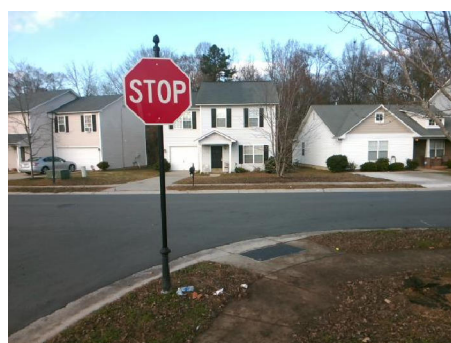
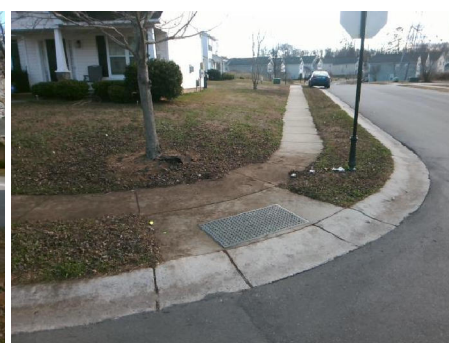
Street 1 Name PEACHTREE RD
 Stop Condition-Street 2 None
 Street 2 Name HARRIER RD
 Stop Condition-Street 1 StopSign
