# Access Compliance Report

## Public Rights-of-Way

### (Curb Ramps)

Intersection ID: N/A	Main Street: BRADSTREET COMMONS WY	Cross Street: COZEN WY	Location: NE
ADA ID: 5CF7A22CB93C	Ramp Type: Combination1Diag	Initial Pass/Fail: Fail	Overall Compliance: No
Severity Score: 0			
Codes/Mitigation Info/Possible Solution		Field Measurements/Component Compliance

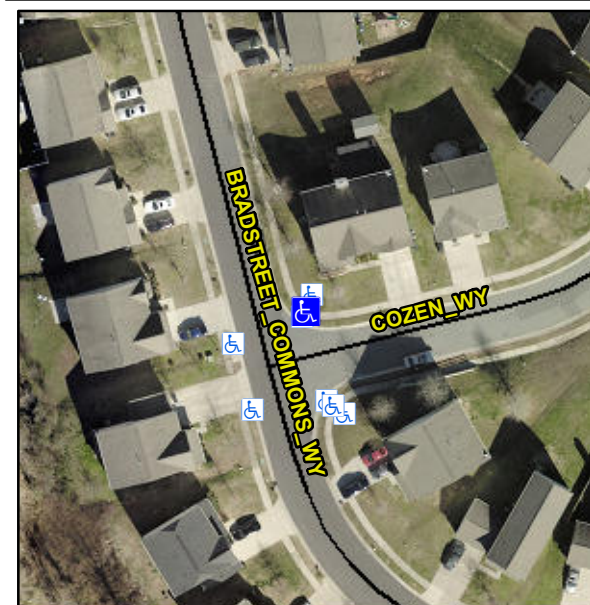
**Not Found, R304.5.1, R304.5.3**

Compliance	Description	Data	Compliance	Description	Data
N/A	Ramp Length LT (in)	41.5	N/A	Ramp Length RT (in)	40.0
Yes	Ramp Width LT (in)	48.0	Yes	Ramp Width RT (in)	48.0
Yes	Ramp Slope LT (%)	5.0	Yes	Ramp Slope RT (%)	2.2
No	Ramp XSlope LT (%)	4.7	No	Ramp XSlope RT (%)	4.2
N/A	Ramp Length (in)	48.0	Yes	Ramp Slope (%)	6.3
No	Ramp Width (in)	47.5	No	Ramp XSlope (%)	3.0
N/A	Flare Type LT	N/A	N/A	Flare Type RT	N/A
N/A	Flare Slope LT (%)	N/A	N/A	Flare Slope RT (%)	N/A
N/A	Flare Traversable LT?	N/A	N/A	Flare Traversable RT?	N/A
N/A	Landing Length (in)	N/A	N/A	DWS Provided?	N/A
N/A	Landing Width (in)	N/A	N/A	DWS Contrast?	N/A
N/A	Landing Slope (%)	N/A	N/A	DWS Length (in)	N/A
N/A	Landing X Slope (%)	N/A	N/A	DWS Full Width?	N/A
N/A	Landing Curb? (Y/N)	N/A	N/A	DWS Offset (in)	N/A
N/A	Shared Landing?	N/A			
N/A	Gutter Ponding?	N/A	N/A	Gutter Slope (%)	N/A
N/A	Gutter Lip Ht (in)	N/A	N/A	Gutter X Slope (%)	N/A
N/A	Painted X Walk1?	No	N/A	Painted X Walk2?	No

X Walk 1 Direction	To W		X Walk 2 Direction	To S
	X Walk 1 Width (in)	N/A		X Walk 2 Width (in)	N/A
	X Walk 1 Slope (%)	7.8		X Walk 2 Slope (%)	10.5
	X Walk 1 X Slope (%)	6.2		X Walk 2 X Slope (%)	5.6
N/A	Ramp inside XWalk1?	N/A	N/A	Ramp inside XWalk2?	N/A
	Road Slope (%)	3.6		Clear Space?	N/A
	Road X Slope (%)	9.0	N/A	Clear Space to XWalk (in)	N/A
			N/A	Any Obstruction?	N/A
				Obstruction Type	N/A
			N/A	Storm Grate/Utility Hazard?	N/A
				Storm Grate/Utility Type	N/A
Yes	Surface Condition? (G/P)	Good			
	Curb Slope (%)	11.9

**Remove & Replace Curb Ramp With Two New Directional Ramps or Equivalent.**
