Access Compliance Report

Public Rights-of-Way

(Curb Ramps)

Intersection ID: 50579	Main Street: GREAT_LAUREL_RD	Cross Street: PAPER_TREE_RD	Location: E
ADA ID: 5D0EFB0ECD8	Ramp Type: Perp	Initial Pass/Fail: Fail	Overall Compliance: No
Severity Score: 22.5			
Codes/Mitigation Info/Possible Solution		Field Measurements/Component Compliance

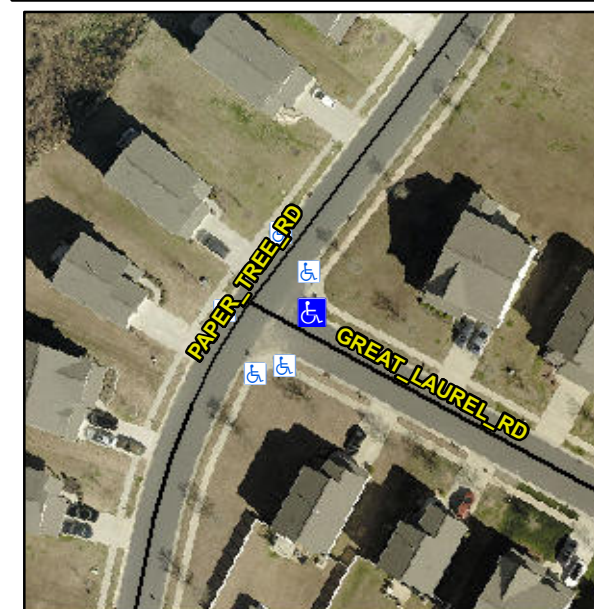
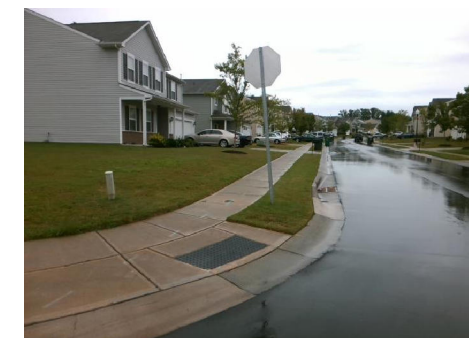
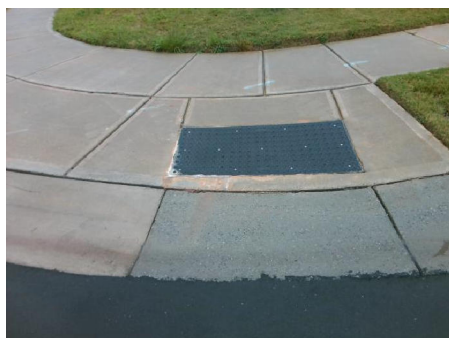
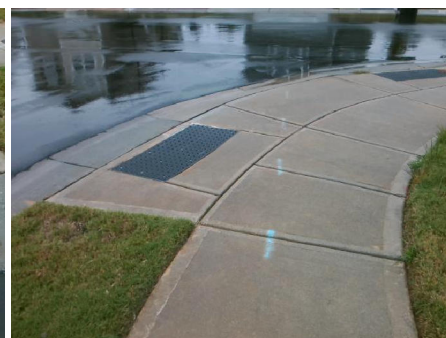
R304.5.1, R304.2.2, R304.5.3

Compliance	Description	Data	Compliance	Description	Data
N/A	Ramp Length (in)	49.0	No	Ramp Slope (%)	9.0
No	Ramp Width (in)	47.5	No	Ramp XSlope (%)	4.5
N/A	Flare Type LT	N/A	N/A	Flare Type RT	N/A
N/A	Flare Slope LT (%)	N/A	N/A	Flare Slope RT (%)	N/A
N/A	Flare Traversable LT?	N/A	N/A	Flare Traversable RT?	N/A
N/A	Landing Length (in)	N/A	N/A	DWS Provided?	N/A
N/A	Landing Width (in)	N/A	N/A	DWS Contrast?	N/A
N/A	Landing Slope (%)	N/A	N/A	DWS Length (in)	N/A
N/A	Landing X Slope (%)	N/A	N/A	DWS Full Width?	N/A
N/A	Landing Curb? (Y/N)	N/A	N/A	DWS Offset (in)	N/A
N/A	Shared Landing?	N/A			
N/A	Gutter Ponding?	N/A	N/A	Gutter Slope (%)	N/A
N/A	Gutter Lip Ht (in)	N/A	N/A	Gutter X Slope (%)	N/A
N/A	Painted X Walk1?	No	N/A	Painted X Walk2?	N/A
	X Walk 1 Direction	To S		X Walk 2 Direction	N/A
N/A	X Walk 1 Width (in)	N/A	N/A	X Walk 2 Width (in)	N/A
	X Walk 1 Slope (%)	1.8		X Walk 2 Slope (%)	N/A
	X Walk 1 X Slope (%)	2.0		X Walk 2 X Slope (%)	N/A

Remove & Replace Entire Ramp.
