# Access Compliance Report

## Public Rights-of-Way

| Intersection ID: 51071 | Main Street: KEMPSFORD_DR | Cross Street: GRICKLADE_DR | Location: NE |
| ADA ID: 5D13516305AF | Ramp Type: Perp | Initial Pass/Fail: Fail | Overall Compliance: No |

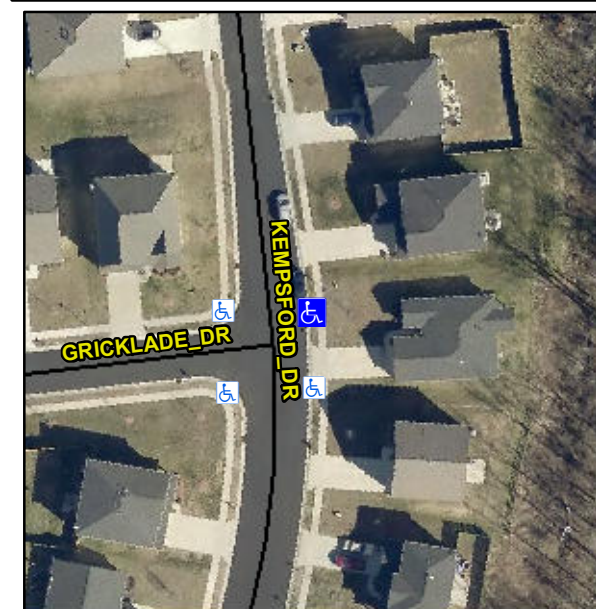
**Not Found, R304.2.2, R304.5.3**

| Compliance | Description | Data | Compliance | Description | Data |
|---|---|---|---|---|---|
| N/A | Ramp Length (in) | 51.0 | No | Ramp Slope (%) | 12.0 |
| Yes | Ramp Width (in) | 48.0 | No | Ramp XSlope (%) | 3.3 |

**Remove & Replace Entire Ramp.**
