Access Compliance Report

Public Rights-of-Way

(Curb Ramps)

Intersection ID: 20224	Main Street: DINGESS_RD	Cross Street: KEARNEY_CT	Location: NE
ADA ID: 5D13CCB01EF8	Ramp Type: PerpDiag	Initial Pass/Fail: Fail	Overall Compliance: No
			Severity Score: 48.75

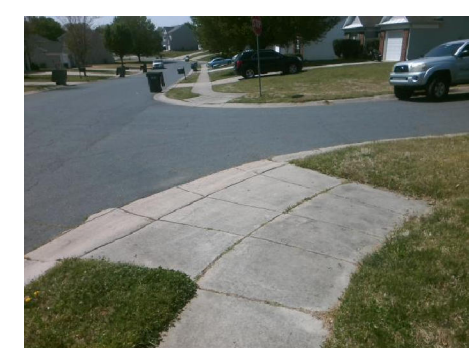
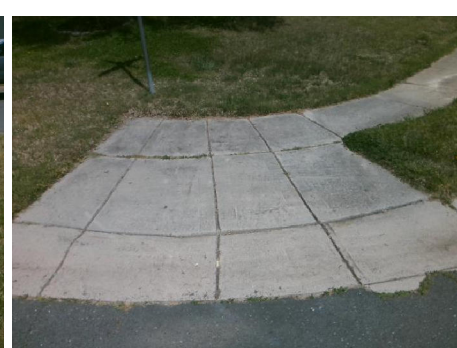
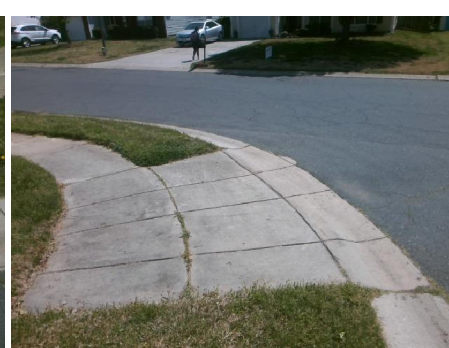
Possible Solutions:		Compliance	Description	Data
	Remove & Replace Curb Ramp With Two New Directional Ramps or Equivalent.		No	Ramp Length (in)	47.5
			No	Ramp Width (in)	26.0
			N/A	Flare Type LT	N/A
			N/A	Flare Slope LT (%)	N/A
			N/A	Flare Traversable LT?	N/A
			N/A	Landing Length (in)	N/A
			N/A	Landing Width (in)	N/A
			N/A	Landing Slope (%)	N/A
			N/A	Landing X Slope (%)	N/A
<p>Surveyor Notes:</p> <p>N/A</p> <p>PROW/ADA:</p> <p>R304.5.1, R304.2.2, R304.5.3</p>			N/A	Flare Type RT	N/A
			N/A	Flare Slope RT (%)	N/A
			N/A	Flare Traversable RT?	N/A
			N/A	DWS Provided?	N/A
			N/A	DWS Contrast?	N/A
			N/A	DWS Length (in)	N/A
			N/A	DWS Full Width?	N/A
			N/A	DWS Offset (in)	N/A
			N/A	Gutter Ponding?	N/A
			N/A	Gutter Lip Ht (in)	N/A
<p>Total Cost:</p> <p>\$ 3200.00</p>			No	Painted X Walk1?	No
			To W	X Walk 2 Direction	To S

N/A	X Walk 2 Width (in)	N/A
			2.7	X Walk 2 Slope (%)	0.5
			2.5	X Walk 2 X Slope (%)	1.5
			N/A	Ramp inside XWalk2?	N/A
			1.7	Clear Space?	N/A
			1.7	Clear Space to XWalk (in)	N/A
			N/A	Storm Grate/Utility Hazard?	N/A
			N/A	Storm Grate/Utility Type	N/A
			N/A	Surface Condition? (G/P)	Good
