Access Compliance Report

Public Rights-of-Way

Intersection ID: 45981	Main Street: LAUREL_VALLEY_RD	Cross Street: MASON_MILL_PL	Location: NE
ADA ID: 5D26966E6FA3	Ramp Type: PerpDiag	Initial Pass/Fail: Fail	Overall Compliance: No
Severity Score: 8.75			
Codes/Mitigation Info/Possible Solution		Field Measurements/Component Compliance

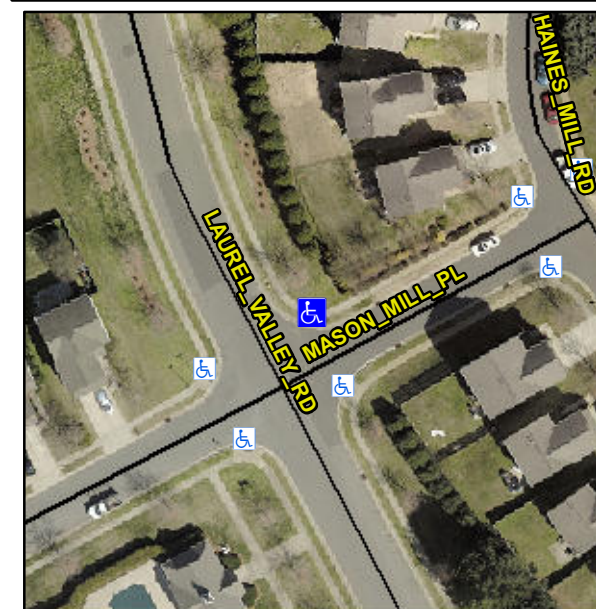
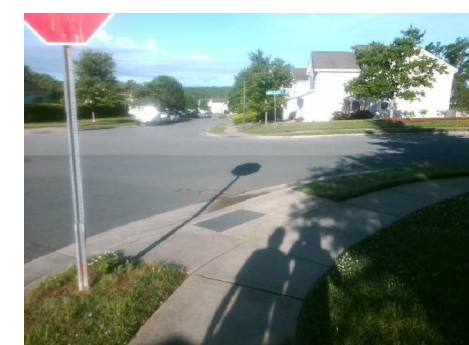
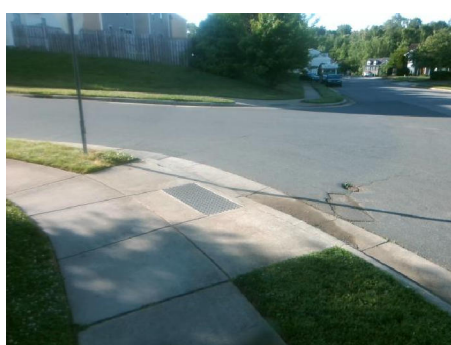
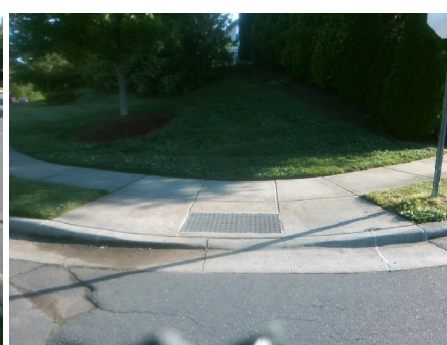
Compliance	Description	Data	Compliance	Description	Data
N/A	Ramp Length (in)	48.0	Yes	Ramp Slope (%)	5.4
No	Ramp Width (in)	47.0	Yes	Ramp XSlope (%)	1.9
N/A	Flare Type LT	N/A	N/A	Flare Type RT	N/A
N/A	Flare Slope LT (%)	N/A	N/A	Flare Slope RT (%)	N/A
N/A	Flare Traversable LT?	N/A	N/A	Flare Traversable RT?	N/A
N/A	Landing Length (in)	N/A	N/A	DWS Provided?	N/A
N/A	Landing Width (in)	N/A	N/A	DWS Contrast?	N/A
N/A	Landing Slope (%)	N/A	N/A	DWS Length (in)	N/A
N/A	Landing X Slope (%)	N/A	N/A	DWS Full Width?	N/A
N/A	Landing Curb? (Y/N)	N/A	N/A	DWS Offset (in)	N/A
N/A	Shared Landing?	N/A			
N/A	Gutter Ponding?	N/A	N/A	Gutter Slope (%)	N/A
N/A	Gutter Lip Ht (in)	N/A	N/A	Gutter X Slope (%)	N/A
N/A	Painted X Walk1?	No	N/A	Painted X Walk2?	No
	X Walk 1 Direction	To W		X Walk 2 Direction	To S
N/A	X Walk 1 Width (in)	N/A	N/A	X Walk 2 Width (in)	N/A
	X Walk 1 Slope (%)	1.4		X Walk 2 Slope (%)	1.6
	X Walk 1 X Slope (%)	1.1		X Walk 2 X Slope (%)	2.4

N/A	Ramp inside XWalk1?	N/A	N/A	Ramp inside XWalk2?	N/A
	Road Slope (%)	1.7	N/A	Clear Space?	N/A
	Road X Slope (%)	4.0	N/A	Clear Space to XWalk (in)	N/A
N/A	Any Obstructions?	N/A	N/A	Storm Grate/Utility Hazard?	N/A
	Obstruction Type			Storm Grate/Utility Type	
		N/A			N/A
			Yes	Surface Condition? (G/P)	Good

Remove & Replace Curb Ramp With Two New Directional Ramps or Equivalent.
