# Access Compliance Report

## Public Rights-of-Way

### (Curb Ramps)

Intersection ID: 10023486	Main Street: CIRCUMFERENTIAL_RD	Cross Street: N/A	Location: NW
ADA ID: 5D29D5D5306D	Ramp Type: Directional1	Initial Pass/Fail: Fail	Overall Compliance: No
		Severity Score: 10

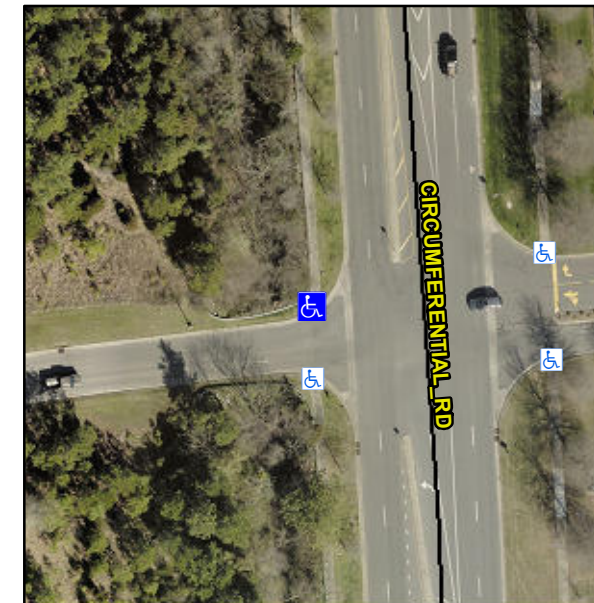
Compliance	Description	Data	Compliance	Description	Data
N/A	Ramp Length (in)	66.0	N/A	Grade Break?	N/A
No	Ramp Width (in)	44.5	N/A	Grade Break Slope (%)	0.0
Yes	Ramp Slope (%)	1.5	N/A	Grade Break XSlope (%)	0.0
No	Ramp XSlope (%)	5.0			
N/A	Flare Type LT	N/A	N/A	Flare Type RT	N/A
N/A	Flare Slope LT (%)	N/A	N/A	Flare Slope RT (%)	0.0
N/A	Flare Traversable LT?	N/A	N/A	Flare Traversable RT?	N/A
N/A	Landing Length (in)	0.0	N/A	DWS Provided?	N/A
N/A	Landing Width (in)	0.0	N/A	DWS Contrast?	N/A
N/A	Landing Slope (%)	0.0	N/A	DWS Length (in)	N/A
N/A	Landing X Slope (%)	0.0	N/A	DWS Full Width?	N/A
N/A	Landing Curb? (Y/N)	N/A	N/A	DWS Offset LT (in)	N/A
N/A	Shared Landing?	N/A	N/A	DWS Offset RT (in)	N/A
N/A	Gutter Ponding?	0.0	N/A	Gutter Slope (%)	N/A
N/A	Gutter Lip Ht (in)	0.0	N/A	Gutter X Slope (%)	N/A
N/A	Painted X Walk1?	No		Road Slope (%)	1.3
	X Walk 1 Direction	To S		Road X Slope (%)	0.7
	X Walk 1 Width (in)	N/A		Clear Space?	N/A

X Walk 1 Slope (%)	1.3	N/A	Clear Space to XWalk (in)	N/A
	X Walk 1 X Slope (%)	0.7	N/A	Storm Grate/Utility Hazard?	N/A
N/A	Ramp inside XWalk1?	N/A		Storm Grate/Utility Type	
N/A	Any Obstructions?	N/A			N/A
	Obstruction Type		Yes	Surface Condition? (G/P)	Good
			N/A	Curb Slope (%)	8.9

**Remove & Replace Entire Ramp.**

**R304.5.1, R304.5.3**
