# Access Compliance Report

## Public Rights-of-Way

### (Curb Ramps)

| Intersection ID: 50707 | Main Street: CONGREGATION_DR | Cross Street: BROTHERLY_LN | Location: S |

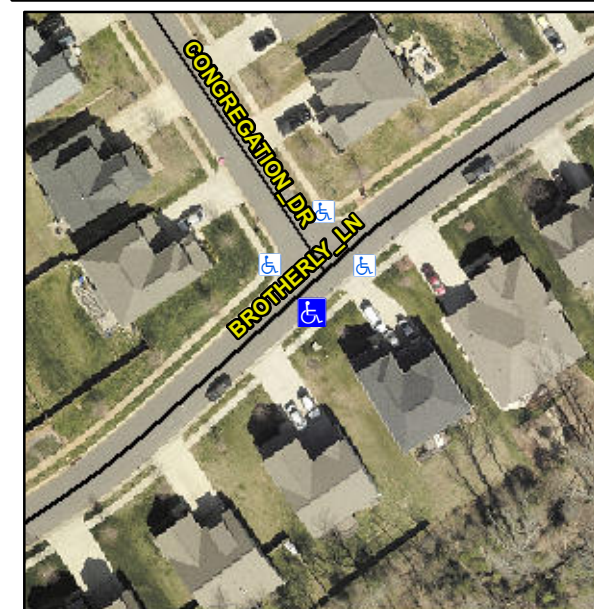
| ADA ID: 5D3389115E55 | Ramp Type: Perp | Initial Pass/Fail: Fail | Overall Compliance: No |
| Severity Score: 21.25 | | | |

**Not Found, R304.5.1, R304.2.2**

| Compliance | Description | Data | Compliance | Description | Data |
|---|---|---|---|---|---|
| N/A | Ramp Length (in) | 48.0 | No | Ramp Slope (%) | 9.0 |
| No | Ramp Width (in) | 47.0 | Yes | Ramp XSlope (%) | 0.3 |

**Remove & Replace Entire Ramp.**

Total Cost: \$ 1850.00
