Access Compliance Report

Public Rights-of-Way

(Curb Ramps)

| Intersection ID: 2874 | Main Street: HORNBEAM_CT | Cross Street: LADY_BANK_DR | Location: SE |

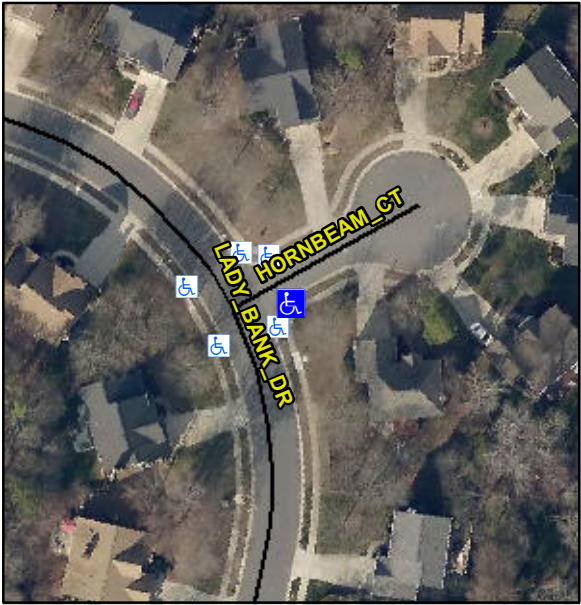
| ADA ID: 5D38D1FA26C7 | Ramp Type: Perp | Initial Pass/Fail: Fail | Overall Compliance: No |

| Codes/Mitigation Info/Possible Solution | | | Field Measurements/Component Compliance | | |
|--|--|--|---|---|---|
| | Remove & Replace Entire Ramp. | | No | Ramp Length (in) | 49.0 |
| | | | No | Ramp Width (in) | 40.0 |
| <p>Surveyor Notes:</p> <p>N/A</p> <p>PROW/ADA:</p> <p>R304.5.1, R304.2.2, R304.5.3</p> | | | N/A | Flare Type RT | N/A |

| Codes/Mitigation Info/Possible Solution | | | Field Measurements/Component Compliance | | |
|--|--|--|---|---|---|
| Total Cost: \$ 1850.00 | | | N/A | Clear Space? | N/A |
