Access Compliance Report

Public Rights-of-Way

(Curb Ramps)

Intersection ID: 53713	Main Street: N_TRYON_ST	Cross Street: PERIWINKLE_HILL_AV	Location: W
ADA ID: 5D3D62EB4E77	Ramp Type: BlendTrans1	Initial Pass/Fail: Fail	Overall Compliance: No
		Severity Score: 8.75

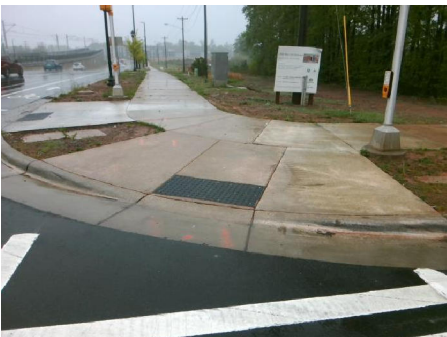
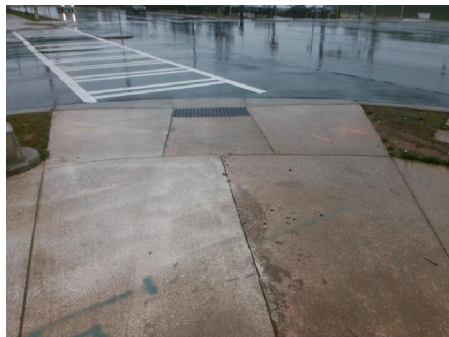
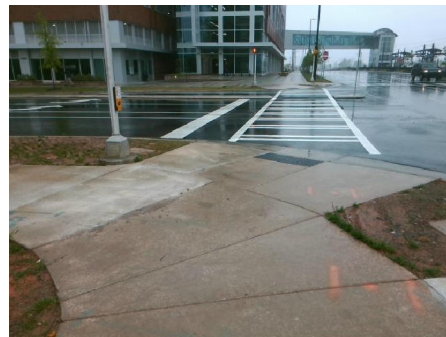
Not Found, R304.5.1

Compliance	Description	Data	Compliance	Description	Data
N/A	Ramp Length (in)	96.0	Yes	BlendTrans Slope (%)	4.3
No	Ramp Width (in)	46.5	Yes	BlendTrans XSlope (%)	1.2
N/A	Flare Type LT	N/A	N/A	Flare Type RT	N/A
N/A	Flare Slope LT (%)	N/A	N/A	Flare Slope RT (%)	N/A
N/A	Flare Traversable LT?	N/A	N/A	Flare Traversable RT?	N/A
N/A	Landing Length (in)	N/A	N/A	DWS Provided?	N/A
N/A	Landing Width (in)	N/A	N/A	DWS Contrast?	N/A
N/A	Landing Slope (%)	N/A	N/A	DWS Length (in)	N/A
N/A	Landing X Slope (%)	N/A	N/A	DWS Full Width?	N/A
N/A	Landing Curb? (Y/N)	N/A	N/A	DWS Offset (in)	N/A
N/A	Shared Landing?	N/A			
N/A	Gutter Ponding?	N/A	N/A	Gutter Slope (%)	N/A
N/A	Gutter Lip Ht (in)	N/A	N/A	Gutter X Slope (%)	N/A
N/A	Painted X Walk1?	Yes	N/A	Painted X Walk2?	N/A
	X Walk 1 Direction	To NE		X Walk 2 Direction	N/A
	X Walk 1 Width (in)	113.0		X Walk 2 Width (in)	N/A
	X Walk 1 Slope (%)	0.8		X Walk 2 Slope (%)	N/A
	X Walk 1 X Slope (%)	2.2		X Walk 2 X Slope (%)	N/A

N/A	Ramp inside XWalk1?	Yes	N/A	Ramp inside XWalk2?	N/A
	Road Slope (%)	2.2		Clear Space?	N/A
	Road X Slope (%)	0.8	N/A	Clear Space to XWalk (in)	N/A
N/A	Any Obstructions?	N/A	N/A	Storm Grate/Utility Hazard?	N/A
	Obstruction Type			Storm Grate/Utility Type	
		N/A			N/A
			Yes	Surface Condition? (G/P)	Good
			No	Curb Slope (%)	9.4

Remove & Replace Curb Ramp With Two New Directional Ramps or Equivalent.
