| Intersection ID: N/A | Main Street: UNION_PACIFIC_AV | Cross Street: BELLE_VERNON_AV | Location: | N |
| ADA ID: 5D4973C70818 | Ramp Type: PerpDiag | Initial Pass/Fail: Fail | Overall Compliance: No | Severity Score: 10 |

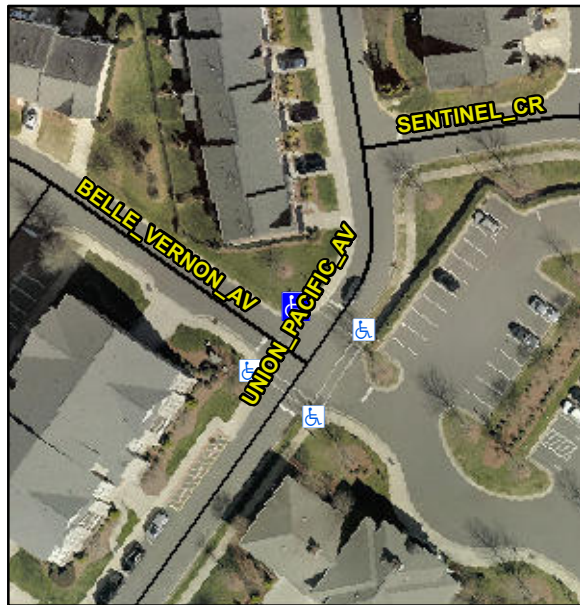
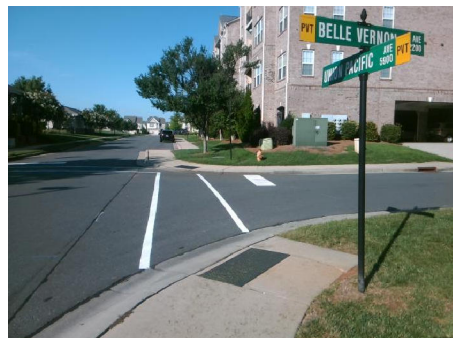
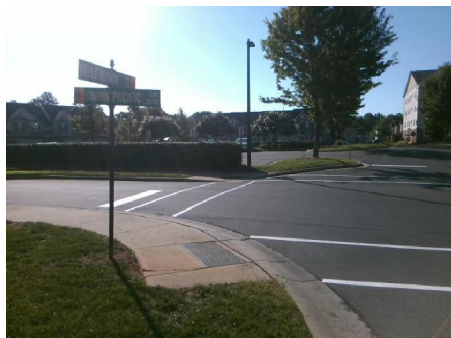
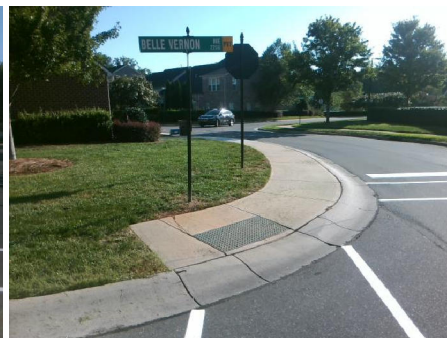
### R304.5.1, R304.5.3

| Compliance | Description | Data | Compliance | Description | Data |
|---|---|---|---|---|---|
| N/A | Ramp Length (in) | 28.5 | Yes | Ramp Slope (%) | 8.0 |
| No | Ramp Width (in) | 47.0 | No | Ramp XSlope (%) | 2.4 |

**Remove & Replace Curb Ramp With Two New Directional Ramps or Equivalent. Restripe Crosswalk.**
