Access Compliance Report

Public Rights-of-Way

(Curb Ramps)

Intersection ID: 15160	Main Street: GRIFFITH_ST	Cross Street: S_TRYON_ST	Location: NE
ADA ID: 5D4ADBD4BFA5	Ramp Type: Perp	Initial Pass/Fail: Fail	Overall Compliance: No
Severity Score: 21.25			
Codes/Mitigation Info/Possible Solution		Field Measurements/Component Compliance

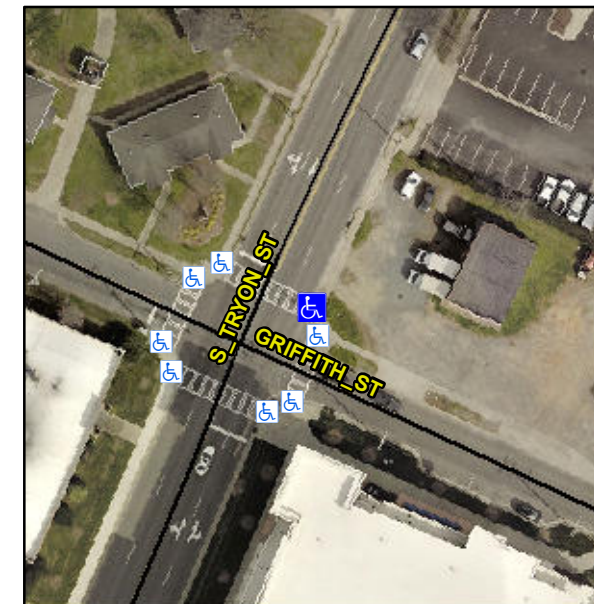
Not Found, R304.5.1, R304.2.2

Compliance	Description	Data	Compliance	Description	Data
N/A	Ramp Length (in)	80.0	No	Ramp Slope (%)	10.8
No	Ramp Width (in)	47.5	Yes	Ramp XSlope (%)	0.4
N/A	Flare Type LT	N/A	N/A	Flare Type RT	N/A
N/A	Flare Slope LT (%)	N/A	N/A	Flare Slope RT (%)	N/A
N/A	Flare Traversable LT?	N/A	N/A	Flare Traversable RT?	N/A
N/A	Landing Length (in)	N/A	N/A	DWS Provided?	N/A
N/A	Landing Width (in)	N/A	N/A	DWS Contrast?	N/A
N/A	Landing Slope (%)	N/A	N/A	DWS Length (in)	N/A
N/A	Landing X Slope (%)	N/A	N/A	DWS Full Width?	N/A
N/A	Landing Curb? (Y/N)	N/A	N/A	DWS Offset (in)	N/A
N/A	Shared Landing?	N/A			
N/A	Gutter Ponding?	N/A	N/A	Gutter Slope (%)	N/A
N/A	Gutter Lip Ht (in)	N/A	N/A	Gutter X Slope (%)	N/A
N/A	Painted X Walk1?	Yes	N/A	Painted X Walk2?	N/A
	X Walk 1 Direction	To NW		X Walk 2 Direction	N/A
N/A	X Walk 1 Width (in)	120.0	N/A	X Walk 2 Width (in)	N/A
	X Walk 1 Slope (%)	2.7		X Walk 2 Slope (%)	N/A
	X Walk 1 X Slope (%)	0.7		X Walk 2 X Slope (%)	N/A

Remove & Replace Entire Ramp.
