Access Compliance Report

Public Rights-of-Way

(Curb Ramps)

| Intersection ID: 52582 | Main Street: NOBLES_AV | Cross Street: N/A | Location: NW |

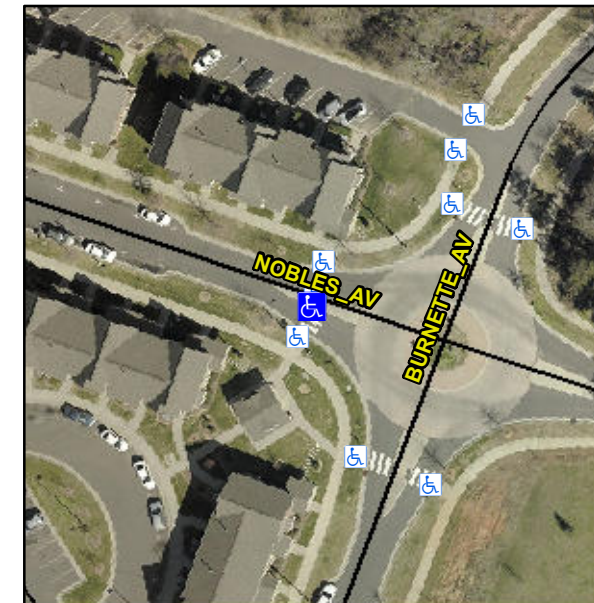
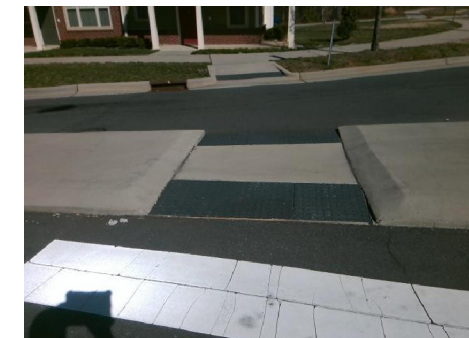
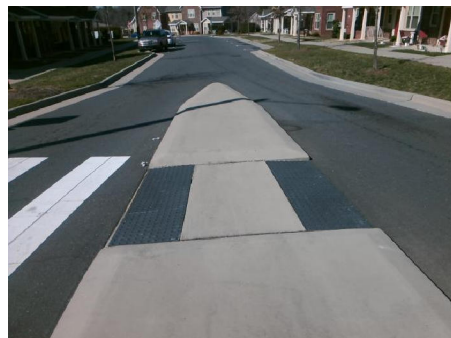
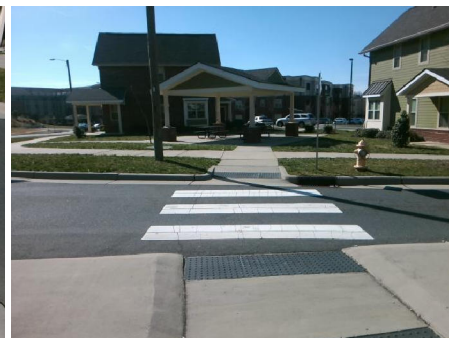
| ADA ID: 5D4C8B7BA314 | Ramp Type: MedianPerp | Initial Pass/Fail: Fail | Overall Compliance: No |

| Compliance | Description | Data | Compliance | Description | Data |
|---|---|---|---|---|---|
| Yes | Ramp Width (in) | 71.5 | No | Ramp XSlope (%) | 3.1 |

Remove & Replace Entire Ramp.

R304.5.3
