# Access Compliance Report

## Public Rights-of-Way

### (Curb Ramps)

Intersection ID: N/A	Main Street: ELM_LN	Cross Street: ELMSTONE_DR	Location: N
ADA ID: 5D4EAFDC3333	Ramp Type: PerpDiag	Initial Pass/Fail: Fail	Overall Compliance: No
Severity Score: 12.5			
Codes/Mitigation Info/Possible Solution		Field Measurements/Component Compliance

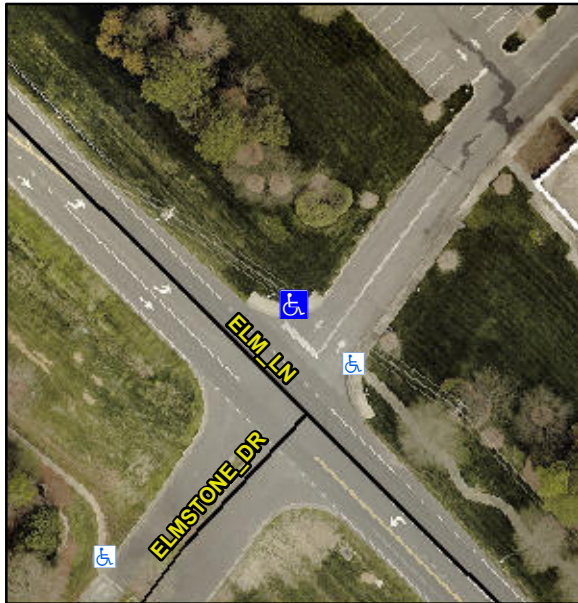
Compliance	Description	Data	Compliance	Description	Data
N/A	Ramp Length (in)	59.0	Yes	Ramp Slope (%)	6.4
Yes	Ramp Width (in)	51.5	No	Ramp XSlope (%)	6.2
N/A	Flare Type LT	N/A	N/A	Flare Type RT	N/A
N/A	Flare Slope LT (%)	N/A	N/A	Flare Slope RT (%)	N/A
N/A	Flare Traversable LT?	N/A	N/A	Flare Traversable RT?	N/A
N/A	Landing Length (in)	N/A	N/A	DWS Provided?	N/A
N/A	Landing Width (in)	N/A	N/A	DWS Contrast?	N/A
N/A	Landing Slope (%)	N/A	N/A	DWS Length (in)	N/A
N/A	Landing X Slope (%)	N/A	N/A	DWS Full Width?	N/A
N/A	Landing Curb? (Y/N)	N/A	N/A	DWS Offset (in)	N/A
N/A	Shared Landing?	N/A			
N/A	Gutter Ponding?	N/A	N/A	Gutter Slope (%)	N/A
N/A	Gutter Lip Ht (in)	N/A	N/A	Gutter X Slope (%)	N/A
N/A	Painted X Walk1?	No	N/A	Painted X Walk2?	No
	X Walk 1 Direction	To SW		X Walk 2 Direction	To SE
N/A	X Walk 1 Width (in)	N/A	N/A	X Walk 2 Width (in)	N/A
	X Walk 1 Slope (%)	8.0		X Walk 2 Slope (%)	1.4
	X Walk 1 X Slope (%)	3.5		X Walk 2 X Slope (%)	7.5

N/A	Ramp inside XWalk1?	N/A	N/A	Ramp inside XWalk2?	N/A
	Road Slope (%)	6.2	N/A	Clear Space?	N/A
	Road X Slope (%)	6.1	N/A	Clear Space to XWalk (in)	N/A
N/A	Any Obstructions?	N/A	N/A	Storm Grate/Utility Hazard?	N/A
	Obstruction Type			Storm Grate/Utility Type	
		N/A			N/A
		Yes		Surface Condition? (G/P)	Good

Possible Solutions:

**Remove & Replace Curb Ramp With Two New Directional Ramps or Equivalent.**

PROW/ADA:

**R304.5.3**
