Access Compliance Report

Public Rights-of-Way

(Curb Ramps)

Intersection ID: N/A	Main Street: LITTLE ROCK RD	Cross Street: N/A	Location: NE
ADA ID: 5D59C42FC6FC	Ramp Type: Directional2	Initial Pass/Fail: Fail	Overall Compliance: No
Codes/Mitigation Info/Possible Solution		Field Measurements/Component Compliance

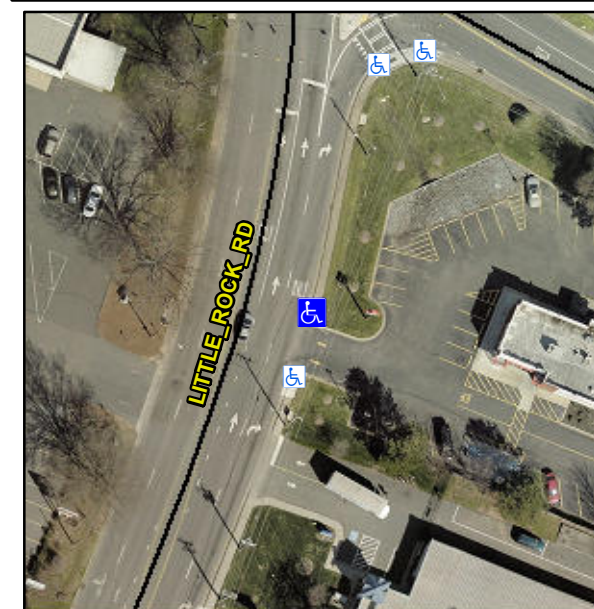
Compliance	Description	Data	Compliance	Description	Data
N/A	Ramp Length (in)	111.0	N/A	Grade Break?	N/A
Yes	Ramp Width (in)	52.0	N/A	Grade Break Slope (%)	0.0
No	Ramp Slope (%)	8.9	N/A	Grade Break XSlope (%)	0.0
No	Ramp XSlope (%)	2.8			
N/A	Flare Type LT	N/A	N/A	Flare Type RT	N/A
N/A	Flare Slope LT (%)	N/A	N/A	Flare Slope RT (%)	0.0
N/A	Flare Traversable LT?	No	N/A	Flare Traversable RT?	No
N/A	Landing Length (in)	0.0	N/A	DWS Provided?	N/A
N/A	Landing Width (in)	0.0	N/A	DWS Contrast?	N/A
N/A	Landing Slope (%)	0.0	N/A	DWS Length (in)	N/A
N/A	Landing X Slope (%)	0.0	N/A	DWS Full Width?	N/A
N/A	Landing Curb? (Y/N)	N/A	N/A	DWS Offset LT (in)	N/A
N/A	Shared Landing?	N/A	N/A	DWS Offset RT (in)	N/A
N/A	Gutter Ponding?	0.0	N/A	Gutter Slope (%)	N/A
N/A	Gutter Lip Ht (in)	0.0	N/A	Gutter X Slope (%)	N/A
N/A	Painted X Walk1?	No		Road Slope (%)	2.1
	X Walk 1 Direction	To S		Road X Slope (%)	0.7
	X Walk 1 Width (in)	N/A		Clear Space?	N/A

X Walk 1 Slope (%)	2.1	N/A	Clear Space to XWalk (in)	N/A
	X Walk 1 X Slope (%)	0.7	N/A	Storm Grate/Utility Hazard?	N/A
N/A	Ramp inside XWalk1?	N/A		Storm Grate/Utility Type	
N/A	Any Obstructions?	N/A			N/A
	Obstruction Type		Yes	Surface Condition? (G/P)	Good
			N/A	Curb Slope (%)	0.7

Remove & Replace Entire Ramp.

R304.2.2, R304.5.3

\$ 1800.00
