# Access Compliance Report

## Public Rights-of-Way

### (Curb Ramps)

Intersection ID: 9448	Main Street: DELTA LAKE DR	Cross Street: E W T HARRIS BV	Location: NE
ADA ID: 5D5F1D3D9740	Ramp Type: PerpDiag	Initial Pass/Fail: Fail	Overall Compliance: No
Codes/Mitigation Info/Possible Solution		Field Measurements/Component Compliance

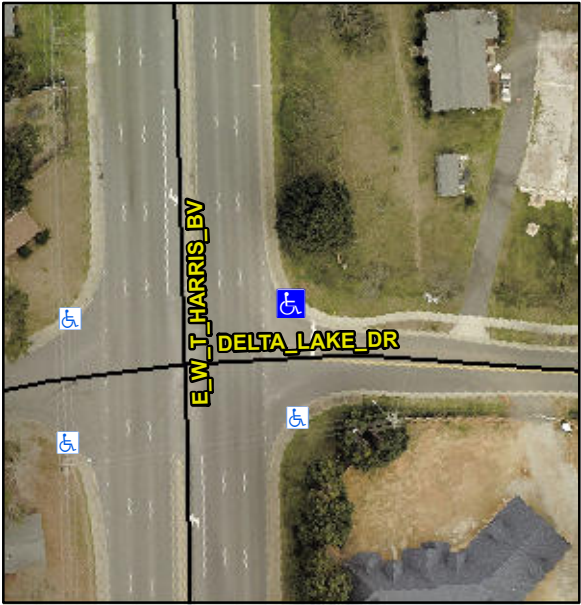
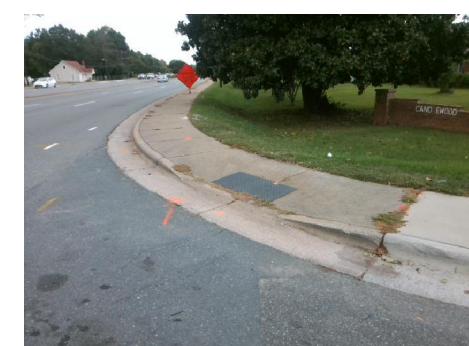
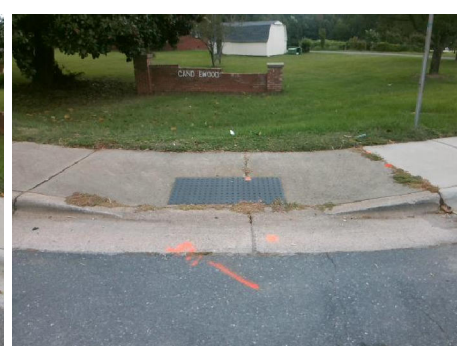
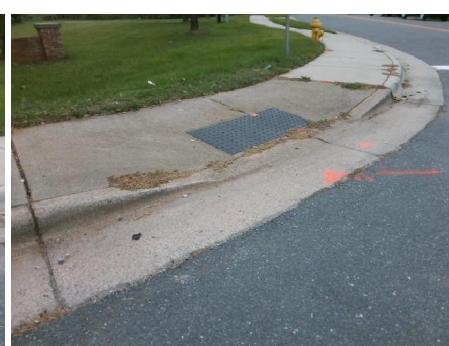
Possible Solutions:		Compliance		Description		Data	Compliance	Description	Data
	Remove & Replace Curb Ramp With Two New Directional Ramps or Equivalent.		N/A		Ramp Length (in)		61.0	No	Ramp Slope (%)	10.1
<p>Surveyor Notes:</p> <p>N/A</p> <p>PROW/ADA:</p> <p>Not Found, R304.2.2, R304.5.3</p>			Yes		Ramp Width (in)		48.0	No	Ramp XSlope (%)	2.9
			N/A		Flare Type LT		N/A	N/A	Flare Type RT	N/A
<p>Total Cost:</p> <p>\$ 3200.00</p>			N/A		Flare Slope LT (%)		N/A	N/A	Flare Slope RT (%)	N/A
			N/A		Flare Traversable LT?		N/A	N/A	Flare Traversable RT?	N/A
			N/A		Landing Length (in)		N/A	N/A	DWS Provided?	N/A
			N/A		Landing Width (in)		N/A	N/A	DWS Contrast?	N/A
			N/A		Landing Slope (%)		N/A	N/A	DWS Length (in)	N/A
			N/A		Landing X Slope (%)		N/A	N/A	DWS Full Width?	N/A
			N/A		Landing Curb? (Y/N)		N/A	N/A	DWS Offset (in)	N/A
			N/A		Shared Landing?		N/A			
			N/A		Gutter Ponding?		N/A	N/A	Gutter Slope (%)	N/A

N/A		Gutter Lip Ht (in)		N/A	N/A	Gutter X Slope (%)	N/A
			N/A		Painted X Walk1?		No	N/A	Painted X Walk2?	No
					X Walk 1 Direction		To W		X Walk 2 Direction	To S
			N/A		X Walk 1 Width (in)		N/A	N/A	X Walk 2 Width (in)	N/A
					X Walk 1 Slope (%)		1.9		X Walk 2 Slope (%)	2.6
					X Walk 1 X Slope (%)		2.0		X Walk 2 X Slope (%)	0.5
			N/A		Ramp inside XWalk1?		N/A	N/A	Ramp inside XWalk2?	N/A
					Road Slope (%)		1.4	N/A	Clear Space?	N/A
					Road X Slope (%)		1.1	N/A	Clear Space to XWalk (in)	N/A
			N/A		Any Obstructions?		N/A	N/A	Storm Grate/Utility Hazard?	N/A
					Obstruction Type				Storm Grate/Utility Type	
							N/A			N/A
								Yes	Surface Condition? (G/P)	Good
