# Access Compliance Report

## Public Rights-of-Way

### (Curb Ramps)

| Intersection ID: 15079 | Main Street: ALBEMARLE_RD | Cross Street: POINT_LAKE_DR | Location: | N |

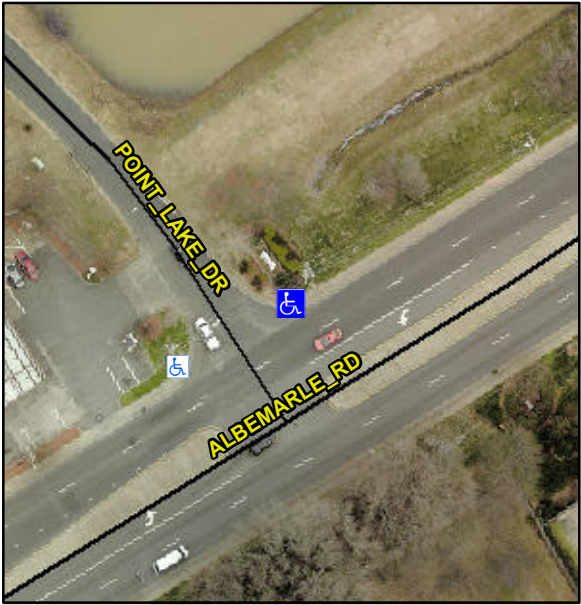
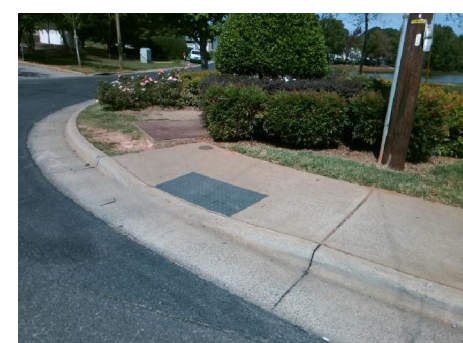
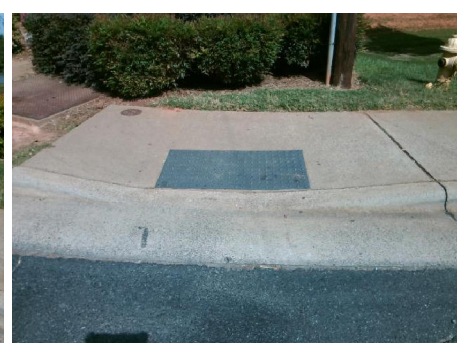
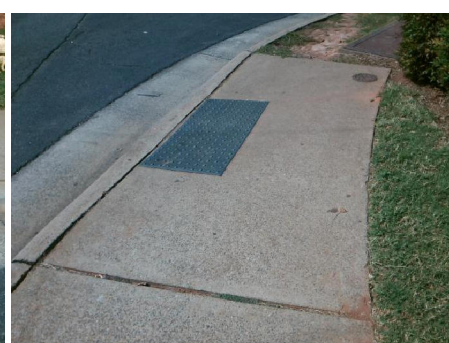
| ADA ID: 5D67514173BA | Ramp Type: Perp | Initial Pass/Fail: Fail | Overall Compliance: No | Severity Score: 21.25 |

| Codes/Mitigation Info/Possible Solution | | | Field Measurements/Component Compliance | | |
|---|---|--|---|---|---|
| | <b>Remove &amp; Replace Entire Ramp.</b> | | <b>No</b> | Ramp Length (in) | <b>61.0</b> |
| | | | <b>No</b> | Ramp Width (in) | <b>47.0</b> |
| <p>Surveyor Notes:</p> <p><b>N/A</b></p> <p>PROW/ADA:</p> <p><b>Not Found, R304.5.1, R304.2.2</b></p> | | | <b>N/A</b> | Flare Type RT | <b>N/A</b> |

| Codes/Mitigation Info/Possible Solution | | | Field Measurements/Component Compliance | | |
|---|---|--|---|---|---|
| | Possible Solutions: | | <b>Compliance</b> | <b>Description</b> | <b>Data</b> |
| <p>Total Cost:</p> <p><b>\$ 1850.00</b></p> | | | <b>No</b> | Painted X Walk1? | <b>N/A</b> |
