# Access Compliance Report

## Public Rights-of-Way

### (Curb Ramps)

Intersection ID: 24384	Main Street: BIRNEN_DR	Cross Street: N_VICKSBURG_PARK_CT	Location: E
ADA ID: 5D7D86F0D5ED	Ramp Type: PerpDiag	Initial Pass/Fail: Fail	Overall Compliance: No
Severity Score: 26.25			
Codes/Mitigation Info/Possible Solution		Field Measurements/Component Compliance

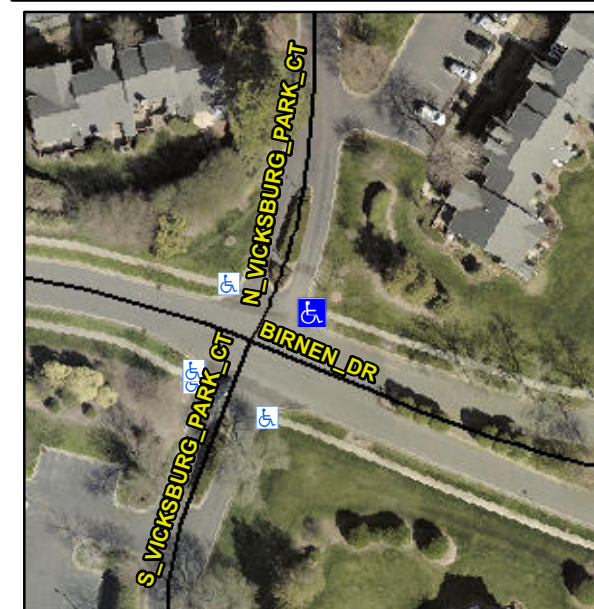
Compliance	Description	Data	Compliance	Description	Data
N/A	Ramp Length (in)	41.5	No	Ramp Slope (%)	13.0
Yes	Ramp Width (in)	48.0	No	Ramp XSlope (%)	4.3
N/A	Flare Type LT	N/A	N/A	Flare Type RT	N/A
N/A	Flare Slope LT (%)	N/A	N/A	Flare Slope RT (%)	N/A
N/A	Flare Traversable LT?	N/A	N/A	Flare Traversable RT?	N/A
N/A	Landing Length (in)	N/A	N/A	DWS Provided?	N/A
N/A	Landing Width (in)	N/A	N/A	DWS Contrast?	N/A
N/A	Landing Slope (%)	N/A	N/A	DWS Length (in)	N/A
N/A	Landing X Slope (%)	N/A	N/A	DWS Full Width?	N/A
N/A	Landing Curb? (Y/N)	N/A	N/A	DWS Offset (in)	N/A
N/A	Shared Landing?	N/A			
N/A	Gutter Ponding?	N/A	N/A	Gutter Slope (%)	N/A
N/A	Gutter Lip Ht (in)	N/A	N/A	Gutter X Slope (%)	N/A
N/A	Painted X Walk1?	No	N/A	Painted X Walk2?	No
	X Walk 1 Direction	To NW		X Walk 2 Direction	To SW
N/A	X Walk 1 Width (in)	N/A	N/A	X Walk 2 Width (in)	N/A
	X Walk 1 Slope (%)	1.5		X Walk 2 Slope (%)	0.0
	X Walk 1 X Slope (%)	0.5		X Walk 2 X Slope (%)	1.2

N/A	Ramp inside XWalk1?	N/A	N/A	Ramp inside XWalk2?	N/A
	Road Slope (%)	0.2	N/A	Clear Space?	N/A
	Road X Slope (%)	1.4	N/A	Clear Space to XWalk (in)	N/A
N/A	Any Obstructions?	N/A	N/A	Storm Grate/Utility Hazard?	N/A
	Obstruction Type			Storm Grate/Utility Type	
		N/A			N/A
		Yes		Surface Condition? (G/P)	Good

**Remove & Replace Curb Ramp With Two New Directional Ramps or Equivalent.**

**R304.2.2, R304.5.3**
