Access Compliance Report

Public Rights-of-Way

(Curb Ramps)

Intersection ID: 5250	Main Street: AUSTIN RIDGE LN	Cross Street: CAMERON SPRING RD	Location: S
ADA ID: 5D898976D92E	Ramp Type: Perp	Initial Pass/Fail: Fail	Overall Compliance: No
Severity Score: 22.5			
Codes/Mitigation Info/Possible Solution		Field Measurements/Component Compliance

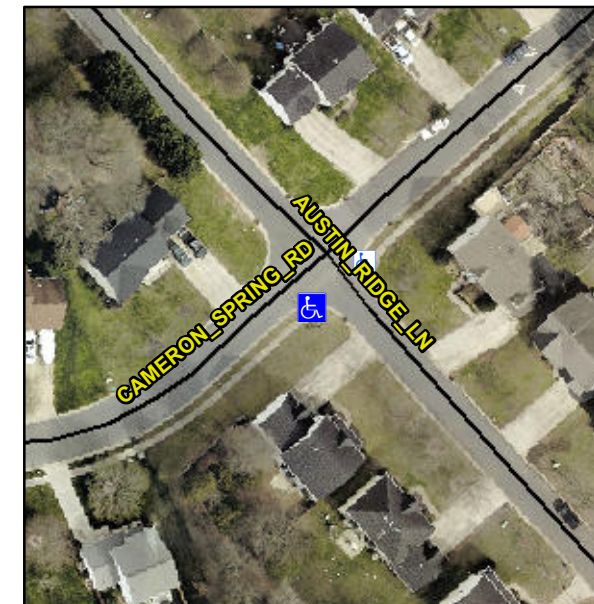
Not Found, R304.5.1, R304.2.2, R304.5.3

Compliance	Description	Data	Compliance	Description	Data
N/A	Ramp Length (in)	43.0	No	Ramp Slope (%)	8.9
No	Ramp Width (in)	41.0	No	Ramp XSlope (%)	3.3
N/A	Flare Type LT	N/A	N/A	Flare Type RT	N/A
N/A	Flare Slope LT (%)	N/A	N/A	Flare Slope RT (%)	N/A
N/A	Flare Traversable LT?	N/A	N/A	Flare Traversable RT?	N/A
N/A	Landing Length (in)	N/A	N/A	DWS Provided?	N/A
N/A	Landing Width (in)	N/A	N/A	DWS Contrast?	N/A
N/A	Landing Slope (%)	N/A	N/A	DWS Length (in)	N/A
N/A	Landing X Slope (%)	N/A	N/A	DWS Full Width?	N/A
N/A	Landing Curb? (Y/N)	N/A	N/A	DWS Offset (in)	N/A
N/A	Shared Landing?	N/A			
N/A	Gutter Ponding?	N/A	N/A	Gutter Slope (%)	N/A
N/A	Gutter Lip Ht (in)	N/A	N/A	Gutter X Slope (%)	N/A
N/A	Painted X Walk1?	No	N/A	Painted X Walk2?	N/A
	X Walk 1 Direction	To NE		X Walk 2 Direction	N/A
N/A	X Walk 1 Width (in)	N/A	N/A	X Walk 2 Width (in)	N/A
	X Walk 1 Slope (%)	4.0		X Walk 2 Slope (%)	N/A
	X Walk 1 X Slope (%)	3.2		X Walk 2 X Slope (%)	N/A

N/A	Ramp inside XWalk1?	N/A	N/A	Ramp inside XWalk2?	N/A
	Road Slope (%)	N/A	N/A	Clear Space?	N/A
	Road X Slope (%)	N/A	N/A	Clear Space to XWalk (in)	N/A
N/A	Any Obstructions?	N/A	N/A	Storm Grate/Utility Hazard?	N/A
	Obstruction Type			Storm Grate/Utility Type	
		N/A			N/A
			Yes	Surface Condition? (G/P)	Good

Possible Solutions:

Remove & Replace Entire Ramp.
