Access Compliance Report Public Rights-of-Way (Curb Ramps)

Intersection ID: N/A Main Street: STEPHENDALE DR **Cross Street: HOOKSTON_LN** Location: SE ADA ID: 5D9E24C1D0B9 Ramp Type: Directional1 Initial Pass/Fail: Fail **Overall Compliance: No Severity Score:** 8.75

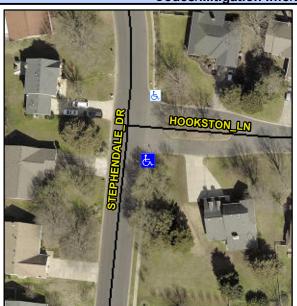
Field Measurements/Component Compliance					
Compliance Description			Comp	liance Description	Data
N/A	Ramp Length (in)	42.0	N/A	Grade Break?	N/A
No	Ramp Width (in)	42.0	N/A	Grade Break Slope (%)	0.0
Yes	Ramp Slope (%)	5.4	N/A	Grade Break XSlope (%)	0.0
Yes	Ramp XSlope (%)	1.6			
N/A	Flare Type LT	N/A	N/A	Flare Type RT	N/A
N/A	Flare Slope LT (%)	N/A	N/A	Flare Slope RT (%)	0.0
N/A	Flare Traversable LT?	N/A	N/A	Flare Traversable RT?	N/A
N/A	Landing Length (in)	0.0	N/A	DWS Provided?	N/A
N/A	Landing Width (in)	0.0	N/A	DWS Contrast?	N/A
N/A	Landing Slope (%)	0.0	N/A	DWS Length (in)	N/A
N/A	Landing X Slope (%)	0.0	N/A	DWS Full Width?	N/A
N/A	Landing Curb? (Y/N)	N/A	N/A	DWS Offset LT (in)	N/A
N/A	Shared Landing?	N/A	N/A	DWS Offset RT (in)	N/A
N/A	Gutter Ponding?	0.0	N/A	Gutter Slope (%)	N/A
N/A	Gutter Lip Ht (in)	0.0	N/A	Gutter X Slope (%)	N/A
N/A	Painted X Walk1?	No		Road Slope (%)	0.
	X Walk 1 Direction	To NW		Road X Slope (%)	3.0

X Walk 1 Width (in)	N/A	l	Clear Space?	N/A
	X Walk 1 Slope (%)	0.1	N/A	Clear Space to XWalk (in)	N/A
	X Walk 1 X Slope (%)	3.0	N/A	Storm Grate/Utility Hazard?	N/A
N/A	Ramp inside XWalk1?	N/A		Storm Grate/Utility Type	
N/A	Any Obstructions?	N/A			N/A
	Obstruction Type		Yes	Surface Condition? (G/P)	Good
		N/A	N/A	Curb Slope (%)	30.9

HOOKSTON LN Street 1 Name StopSign Stop Condition-Street 1 Street 2 Name N/A Stop Condition-Street 2 N/A Possible Solutions: Remove & Replace Entire Ramp. Surveyor Notes: N/A PROW/ADA: R304.5.1
