Access Compliance Report

Public Rights-of-Way

(Curb Ramps)

Intersection ID: 47816	Main Street: ROCKMOOR RIDGE RD	Cross Street: MISTY VIEW CT	Location: NW
ADA ID: 5DA06098E639	Ramp Type: Perp	Initial Pass/Fail: Fail	Overall Compliance: No Severity Score: 33.75

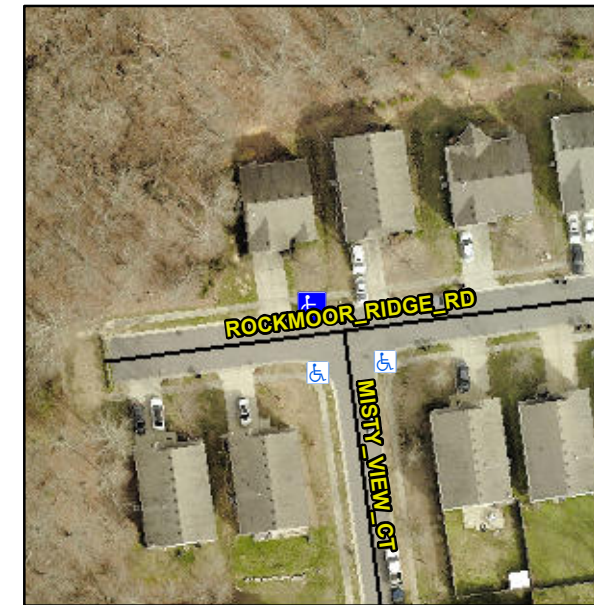
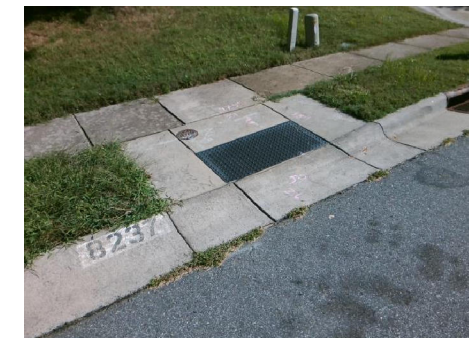
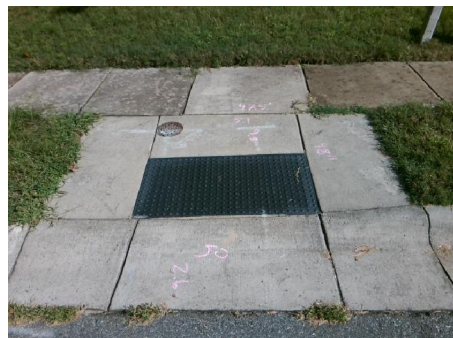
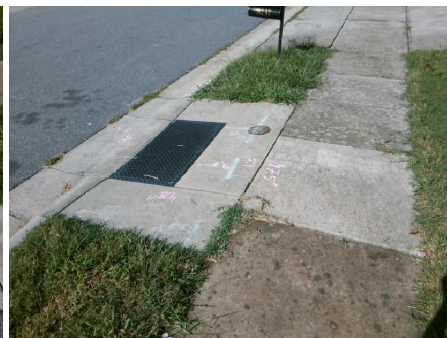
Not Found, R304.5.1, R304.2.2, R304.5.3

Compliance	Description	Data	Compliance	Description	Data
N/A	Ramp Length (in)	48.0	No	Ramp Slope (%)	9.8
No	Ramp Width (in)	47.5	No	Ramp XSlope (%)	5.1
N/A	Flare Type LT	N/A	N/A	Flare Type RT	N/A
N/A	Flare Slope LT (%)	N/A	N/A	Flare Slope RT (%)	N/A
N/A	Flare Traversable LT?	N/A	N/A	Flare Traversable RT?	N/A
N/A	Landing Length (in)	N/A	N/A	DWS Provided?	N/A
N/A	Landing Width (in)	N/A	N/A	DWS Contrast?	N/A
N/A	Landing Slope (%)	N/A	N/A	DWS Length (in)	N/A
N/A	Landing X Slope (%)	N/A	N/A	DWS Full Width?	N/A
N/A	Landing Curb? (Y/N)	N/A	N/A	DWS Offset (in)	N/A
N/A	Shared Landing?	N/A			
N/A	Gutter Ponding?	N/A	N/A	Gutter Slope (%)	N/A
N/A	Gutter Lip Ht (in)	N/A	N/A	Gutter X Slope (%)	N/A
N/A	Painted X Walk1?	No	N/A	Painted X Walk2?	N/A
	X Walk 1 Direction	To S		X Walk 2 Direction	N/A
N/A	X Walk 1 Width (in)	N/A	N/A	X Walk 2 Width (in)	N/A
	X Walk 1 Slope (%)	2.6		X Walk 2 Slope (%)	N/A
	X Walk 1 X Slope (%)	5.0		X Walk 2 X Slope (%)	N/A

N/A	Ramp inside XWalk1?	N/A	N/A	Ramp inside XWalk2?	N/A
	Road Slope (%)	N/A	N/A	Clear Space?	N/A
	Road X Slope (%)	N/A	N/A	Clear Space to XWalk (in)	N/A
N/A	Any Obstructions?	N/A	N/A	Storm Grate/Utility Hazard?	N/A
	Obstruction Type			Storm Grate/Utility Type	
		N/A			N/A
			Yes	Surface Condition? (G/P)	Good

Remove & Replace Entire Ramp.
