Access Compliance Report

Public Rights-of-Way

(Curb Ramps)

Intersection ID: 23815	Main Street: CARMEL_RD	Cross Street: MONTIBELLO_DR	Location: NW
ADA ID: 5DAB6AB9D244	Ramp Type: PerpDiag	Initial Pass/Fail: Fail	Overall Compliance: No
		Severity Score: 10

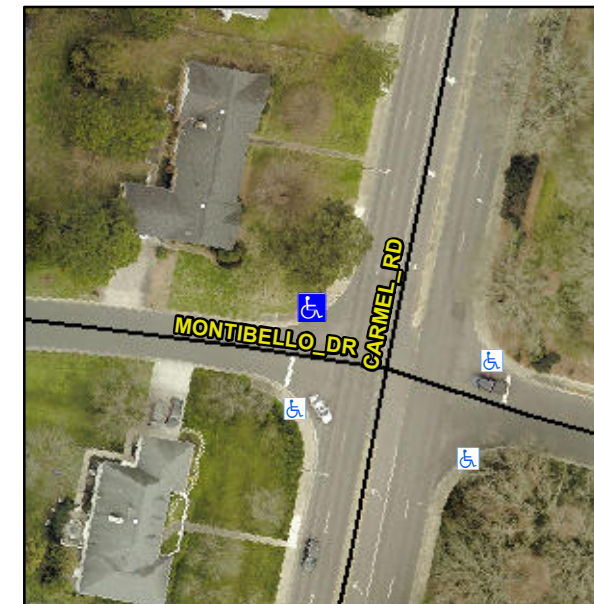
Not Found, R304.5.1, R304.5.3

Compliance	Description	Data	Compliance	Description	Data
N/A	Ramp Length (in)	58.0	Yes	Ramp Slope (%)	6.4
No	Ramp Width (in)	43.0	No	Ramp XSlope (%)	3.2
N/A	Flare Type LT	N/A	N/A	Flare Type RT	N/A
N/A	Flare Slope LT (%)	N/A	N/A	Flare Slope RT (%)	N/A
N/A	Flare Traversable LT?	N/A	N/A	Flare Traversable RT?	N/A
N/A	Landing Length (in)	N/A	N/A	DWS Provided?	N/A
N/A	Landing Width (in)	N/A	N/A	DWS Contrast?	N/A
N/A	Landing Slope (%)	N/A	N/A	DWS Length (in)	N/A
N/A	Landing X Slope (%)	N/A	N/A	DWS Full Width?	N/A
N/A	Landing Curb? (Y/N)	N/A	N/A	DWS Offset (in)	N/A
N/A	Shared Landing?	N/A			
N/A	Gutter Ponding?	N/A	N/A	Gutter Slope (%)	N/A
N/A	Gutter Lip Ht (in)	N/A	N/A	Gutter X Slope (%)	N/A
N/A	Painted X Walk1?	No	N/A	Painted X Walk2?	No
	X Walk 1 Direction	To S		X Walk 2 Direction	To SE
N/A	X Walk 1 Width (in)	N/A	N/A	X Walk 2 Width (in)	N/A
	X Walk 1 Slope (%)	2.3		X Walk 2 Slope (%)	3.9
	X Walk 1 X Slope (%)	2.8		X Walk 2 X Slope (%)	1.5

N/A	Ramp inside XWalk1?	N/A	N/A	Ramp inside XWalk2?	N/A
	Road Slope (%)	2.4	N/A	Clear Space?	N/A
	Road X Slope (%)	4.7	N/A	Clear Space to XWalk (in)	N/A
N/A	Any Obstructions?	N/A	N/A	Storm Grate/Utility Hazard?	N/A
	Obstruction Type			Storm Grate/Utility Type	
		N/A			N/A
			Yes	Surface Condition? (G/P)	Good

Remove & Replace Curb Ramp With Two New Directional Ramps or Equivalent.

Total Cost: \$ 3200.00
