Access Compliance Report

Public Rights-of-Way

(Curb Ramps)

Intersection ID: 10033047	Main Street: NORFOLK_AV	Cross Street: N/A	Location: NW
ADA ID: 5DB078E3913B	Ramp Type: Perp	Initial Pass/Fail: Fail	Overall Compliance: No
		Severity Score: 12.5

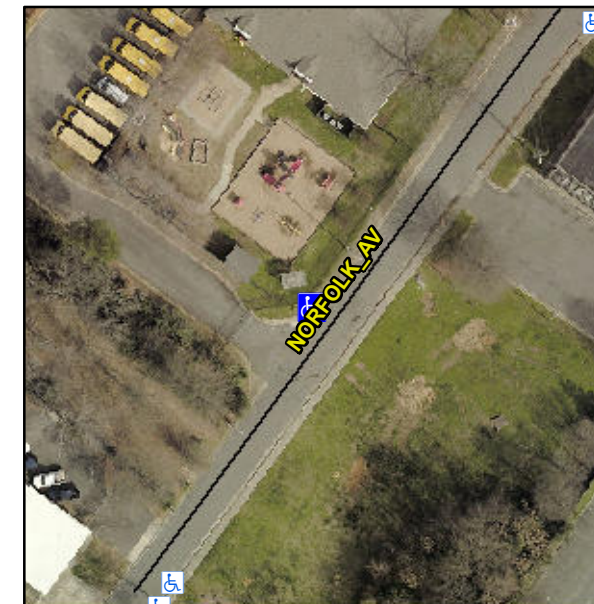
Not Found, R304.5.3

Compliance	Description	Data	Compliance	Description	Data
N/A	Ramp Length (in)	48.0	Yes	Ramp Slope (%)	6.4
Yes	Ramp Width (in)	48.0	No	Ramp XSlope (%)	6.8
N/A	Flare Type LT	N/A	N/A	Flare Type RT	N/A
N/A	Flare Slope LT (%)	N/A	N/A	Flare Slope RT (%)	N/A
N/A	Flare Traversable LT?	N/A	N/A	Flare Traversable RT?	N/A
N/A	Landing Length (in)	N/A	N/A	DWS Provided?	N/A
N/A	Landing Width (in)	N/A	N/A	DWS Contrast?	N/A
N/A	Landing Slope (%)	N/A	N/A	DWS Length (in)	N/A
N/A	Landing X Slope (%)	N/A	N/A	DWS Full Width?	N/A
N/A	Landing Curb? (Y/N)	N/A	N/A	DWS Offset (in)	N/A
N/A	Shared Landing?	N/A			
N/A	Gutter Ponding?	N/A	N/A	Gutter Slope (%)	N/A
N/A	Gutter Lip Ht (in)	N/A	N/A	Gutter X Slope (%)	N/A
N/A	Painted X Walk1?	No	N/A	Painted X Walk2?	N/A
	X Walk 1 Direction	To SE		X Walk 2 Direction	N/A
N/A	X Walk 1 Width (in)	N/A	N/A	X Walk 2 Width (in)	N/A
	X Walk 1 Slope (%)	5.1		X Walk 2 Slope (%)	N/A
	X Walk 1 X Slope (%)	4.7		X Walk 2 X Slope (%)	N/A

N/A	Ramp inside XWalk1?	N/A	N/A	Ramp inside XWalk2?	N/A
	Road Slope (%)	N/A	N/A	Clear Space?	N/A
	Road X Slope (%)	N/A	N/A	Clear Space to XWalk (in)	N/A
N/A	Any Obstructions?	N/A	N/A	Storm Grate/Utility Hazard?	N/A
	Obstruction Type			Storm Grate/Utility Type	
		N/A			N/A
			Yes	Surface Condition? (G/P)	Good

Remove & Replace Entire Ramp.
