Access Compliance Report

Public Rights-of-Way

(Curb Ramps)

Intersection ID: 43739	Main Street: BRIDGEMOUNT_AV	Cross Street: BRIDGEVIEW_LN	Location: SE
ADA ID: 5DB575D018C6	Ramp Type: PerpDiag	Initial Pass/Fail: Fail	Overall Compliance: No
Severity Score: 21.25			
Codes/Mitigation Info/Possible Solution		Field Measurements/Component Compliance

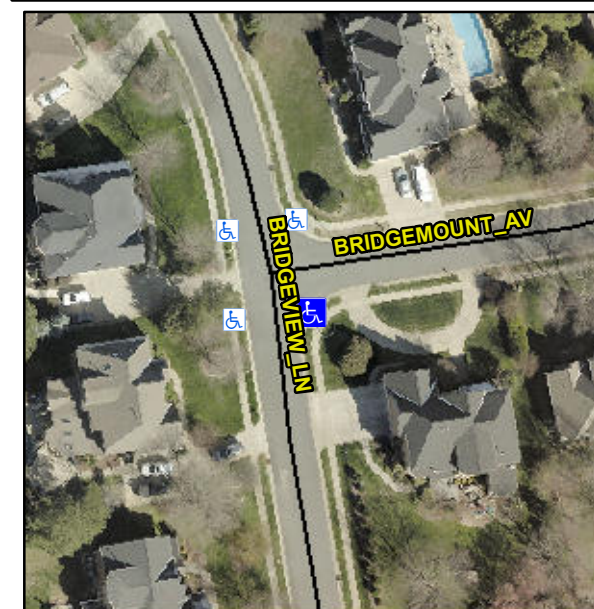
Compliance	Description	Data	Compliance	Description	Data
N/A	Ramp Length (in)	48.0	No	Ramp Slope (%)	9.7
No	Ramp Width (in)	41.0	Yes	Ramp XSlope (%)	0.5
N/A	Flare Type LT	N/A	N/A	Flare Type RT	N/A
N/A	Flare Slope LT (%)	N/A	N/A	Flare Slope RT (%)	N/A
N/A	Flare Traversable LT?	N/A	N/A	Flare Traversable RT?	N/A
N/A	Landing Length (in)	N/A	N/A	DWS Provided?	N/A
N/A	Landing Width (in)	N/A	N/A	DWS Contrast?	N/A
N/A	Landing Slope (%)	N/A	N/A	DWS Length (in)	N/A
N/A	Landing X Slope (%)	N/A	N/A	DWS Full Width?	N/A
N/A	Landing Curb? (Y/N)	N/A	N/A	DWS Offset (in)	N/A
N/A	Shared Landing?	N/A			
N/A	Gutter Ponding?	N/A	N/A	Gutter Slope (%)	N/A
N/A	Gutter Lip Ht (in)	N/A	N/A	Gutter X Slope (%)	N/A
N/A	Painted X Walk1?	No	N/A	Painted X Walk2?	No
	X Walk 1 Direction	To N		X Walk 2 Direction	To W
N/A	X Walk 1 Width (in)	N/A	N/A	X Walk 2 Width (in)	N/A
	X Walk 1 Slope (%)	0.3		X Walk 2 Slope (%)	1.8
	X Walk 1 X Slope (%)	0.1		X Walk 2 X Slope (%)	0.9

N/A	Ramp inside XWalk1?	N/A	N/A	Ramp inside XWalk2?	N/A
	Road Slope (%)	1.0	N/A	Clear Space?	N/A
	Road X Slope (%)	0.3	N/A	Clear Space to XWalk (in)	N/A
N/A	Any Obstructions?	N/A	N/A	Storm Grate/Utility Hazard?	N/A
	Obstruction Type			Storm Grate/Utility Type	
		N/A			N/A
			Yes	Surface Condition? (G/P)	Good

Possible Solutions:

Remove & Replace Curb Ramp With Two New Directional Ramps or Equivalent.
