Access Compliance Report Public Rights-of-Way (Curb Ramps)

Intersection ID: 10036927 Main Street: S SHARON AMITY RD Cross Street: N/A Location: SE Initial Pass/Fail: Fail **Overall Compliance: No** Severity Score: 46.25 ADA ID: 5DC14E5E3225 Ramp Type: PerpDiag

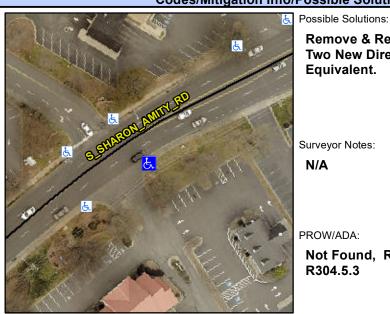
Not Found, R304.5.1, R304.2.2, R304.5.3

Compliance Description Data Compliance Description No N/A Ramp Length (in) 60.0 Ramp Slope (%) No Ramp XSlope (%) No Ramp Width (in) 36.0 N/A N/A Flare Type LT N/A Flare Type RT N/A Flare Slope LT (%) N/A N/A Flare Slope RT (%) N/A Flare Traversable LT? N/A N/A Flare Traversable RT? N/A Landing Length (in) N/A N/A **DWS Provided?** N/A Landing Width (in) N/A N/A **DWS Contrast?** N/A N/A N/A Landing Slope (%) DWS Length (in) N/A Landing X Slope (%) N/A N/A DWS Full Width? N/A Landing Curb? (Y/N) N/A N/A DWS Offset (in) N/A N/A Shared Landing? N/A **Gutter Ponding?** N/A N/A Gutter Slope (%) N/A Gutter Lip Ht (in) 1.0 N/A Gutter X Slope (%) N/A Painted X Walk1? No N/A Painted X Walk2? X Walk 1 Direction To NW X Walk 2 Direction N/A N/A X Walk 2 Width (in) X Walk 1 Width (in) X Walk 1 Slope (%) 0.5 X Walk 2 Slope (%) X Walk 1 X Slope (%) 6.8 X Walk 2 X Slope (%) N/A Ramp inside XWalk1? N/A N/A Ramp inside XWalk2? Road Slope (%) 8.2 N/A Clear Space? N/A Road X Slope (%) 1.2 Clear Space to XWalk (in) N/A N/A N/A Any Obstructions? Storm Grate/Utility Hazard?

S SHARON AMITY RD Street 1 Name Stop Condition-Street 2 **ENTRANCE** Street 2 Name Stop Condition-Street 1 StopSign Remove & Replace Curb Ramp With Two New Directional Ramps or Equivalent.
