Access Compliance Report

Public Rights-of-Way

(Curb Ramps)

Intersection ID: 48073	Main Street: MALLARD_HIGHLANDS_DR	Cross Street: MALLARD_GLEN_DR	Location:	N
ADA ID: 5DCEA3E0E974	Ramp Type: PerpDiag	Initial Pass/Fail: Fail	Overall Compliance: No	Severity Score: 35

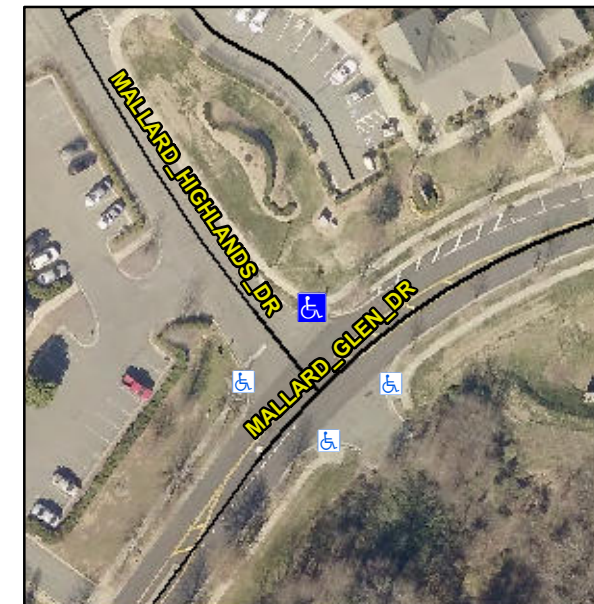
Compliance	Description	Data	Compliance	Description	Data
N/A	Ramp Length (in)	57.0	No	Ramp Slope (%)	13.2
No	Ramp Width (in)	42.5	No	Ramp XSlope (%)	3.2
N/A	Flare Type LT	N/A	N/A	Flare Type RT	N/A
N/A	Flare Slope LT (%)	N/A	N/A	Flare Slope RT (%)	N/A
N/A	Flare Traversable LT?	N/A	N/A	Flare Traversable RT?	N/A
N/A	Landing Length (in)	N/A	N/A	DWS Provided?	N/A
N/A	Landing Width (in)	N/A	N/A	DWS Contrast?	N/A
N/A	Landing Slope (%)	N/A	N/A	DWS Length (in)	N/A
N/A	Landing X Slope (%)	N/A	N/A	DWS Full Width?	N/A
N/A	Landing Curb? (Y/N)	N/A	N/A	DWS Offset (in)	N/A
N/A	Shared Landing?	N/A			
N/A	Gutter Ponding?	N/A	N/A	Gutter Slope (%)	N/A
N/A	Gutter Lip Ht (in)	N/A	N/A	Gutter X Slope (%)	N/A
N/A	Painted X Walk1?	No	N/A	Painted X Walk2?	No
	X Walk 1 Direction	To SW		X Walk 2 Direction	To SE
N/A	X Walk 1 Width (in)	N/A	N/A	X Walk 2 Width (in)	N/A
	X Walk 1 Slope (%)	2.4		X Walk 2 Slope (%)	2.1
	X Walk 1 X Slope (%)	3.1		X Walk 2 X Slope (%)	4.9

N/A	Ramp inside XWalk1?	N/A	N/A	Ramp inside XWalk2?	N/A
	Road Slope (%)	6.0	N/A	Clear Space?	N/A
	Road X Slope (%)	2.0	N/A	Clear Space to XWalk (in)	N/A
N/A	Any Obstructions?	N/A	N/A	Storm Grate/Utility Hazard?	N/A
	Obstruction Type			Storm Grate/Utility Type	
		N/A			N/A
			Yes	Surface Condition? (G/P)	Good

Possible Solutions:

Remove & Replace Curb Ramp With Two New Directional Ramps or Equivalent.

R304.5.1, R304.2.2, R304.5.3
