# Access Compliance Report

## Public Rights-of-Way

### (Curb Ramps)

Intersection ID: 10020667	Main Street: BEACON_VALLEY_ST	Cross Street: N/A	Location: NW
ADA ID: 5DE5F01441E1	Ramp Type: Perpendicular Diagonal	Initial Pass/Fail: Fail	Overall Compliance: No
			Severity Score: 33.75

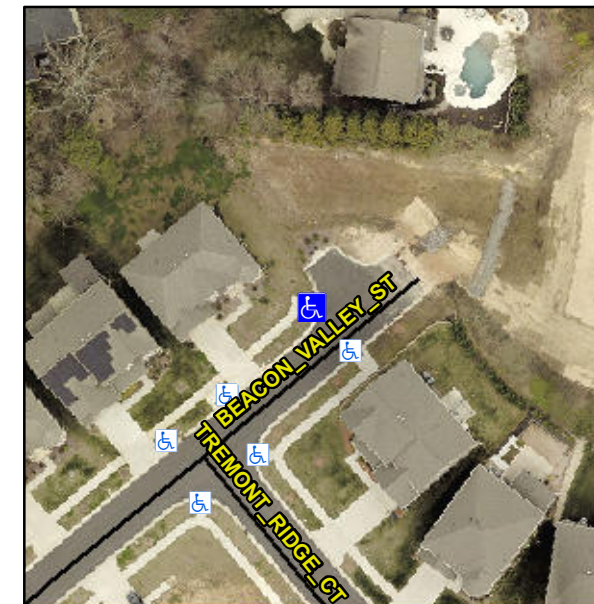
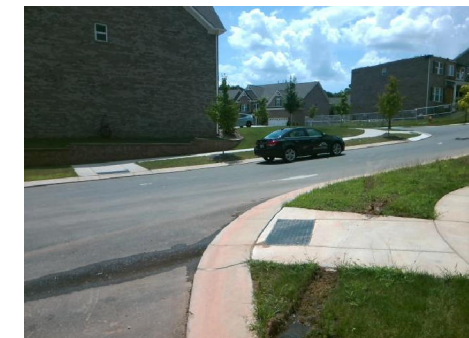
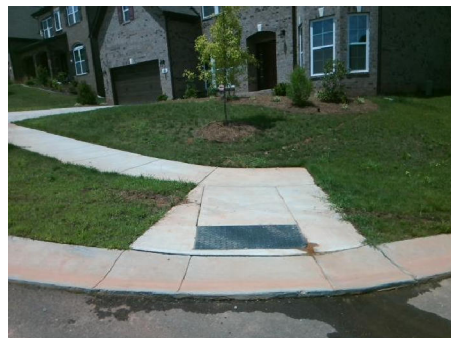
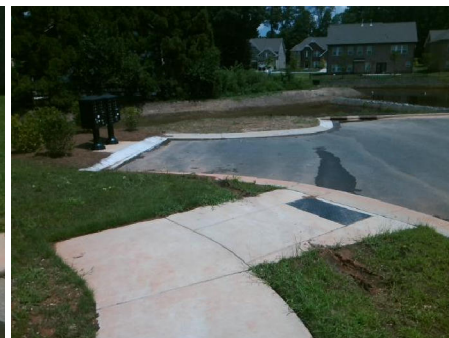
**Not Found, R304.5.1, R304.5.3**

Compliance	Description	Data	Compliance	Description	Data
N/A	Ramp Length (in)	96.0	Yes	Ramp Slope (%)	5.2
No	Ramp Width (in)	46.0	No	Ramp XSlope (%)	7.4
N/A	Flare Type LT	N/A	N/A	Flare Type RT	N/A
N/A	Flare Slope LT (%)	N/A	N/A	Flare Slope RT (%)	N/A
N/A	Flare Traversable LT?	N/A	N/A	Flare Traversable RT?	N/A
N/A	Landing Length (in)	N/A	N/A	DWS Provided?	N/A
N/A	Landing Width (in)	N/A	N/A	DWS Contrast?	N/A
N/A	Landing Slope (%)	N/A	N/A	DWS Length (in)	N/A
N/A	Landing X Slope (%)	N/A	N/A	DWS Full Width?	N/A
N/A	Landing Curb? (Y/N)	N/A	N/A	DWS Offset (in)	N/A
N/A	Shared Landing?	N/A			
N/A	Gutter Ponding?	N/A	N/A	Gutter Slope (%)	N/A
N/A	Gutter Lip Ht (in)	3.0	N/A	Gutter X Slope (%)	N/A
N/A	Painted X Walk1?	No	N/A	Painted X Walk2?	No
	X Walk 1 Direction	To SW		X Walk 2 Direction	To SE
N/A	X Walk 1 Width (in)	N/A	N/A	X Walk 2 Width (in)	N/A
	X Walk 1 Slope (%)	0.7		X Walk 2 Slope (%)	7.1
	X Walk 1 X Slope (%)	6.3		X Walk 2 X Slope (%)	1.4

N/A	Ramp inside XWalk1?	N/A	N/A	Ramp inside XWalk2?	N/A
	Road Slope (%)	8.9	N/A	Clear Space?	N/A
	Road X Slope (%)	6.9	N/A	Clear Space to XWalk (in)	N/A
N/A	Any Obstructions?	N/A	N/A	Storm Grate/Utility Hazard?	N/A
	Obstruction Type			Storm Grate/Utility Type	
		N/A			N/A
			Yes	Surface Condition? (G/P)	Good

**Remove & Replace Curb Ramp With Two New Directional Ramps or Equivalent.**
