# Access Compliance Report

## Public Rights-of-Way

### (Curb Ramps)

Intersection ID: 53745	Main Street: SPRINGWOOD_ESTATE_DR	Cross Street: CANTERBURY_CASTLE_DR	Location: NE
ADA ID: 5DECBCF74054	Ramp Type: Perpendicular	Initial Pass/Fail: Fail	Overall Compliance: No
Severity Score: 21.25			
Codes/Mitigation Info/Possible Solution		Field Measurements/Component Compliance

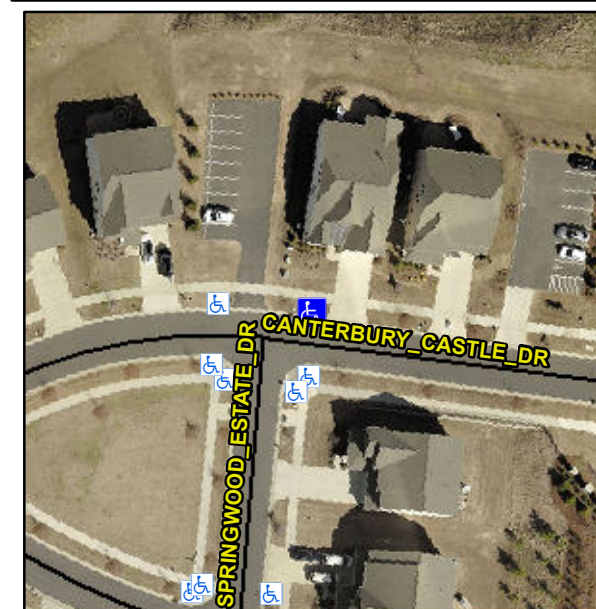
**Not Found, R304.5.1, R304.2.2**

Compliance	Description	Data	Compliance	Description	Data
N/A	Ramp Length (in)	94.5	No	Ramp Slope (%)	9.1
No	Ramp Width (in)	46.5	Yes	Ramp XSlope (%)	1.7
N/A	Flare Type LT	N/A	N/A	Flare Type RT	N/A
N/A	Flare Slope LT (%)	N/A	N/A	Flare Slope RT (%)	N/A
N/A	Flare Traversable LT?	N/A	N/A	Flare Traversable RT?	N/A
N/A	Landing Length (in)	N/A	N/A	DWS Provided?	N/A
N/A	Landing Width (in)	N/A	N/A	DWS Contrast?	N/A
N/A	Landing Slope (%)	N/A	N/A	DWS Length (in)	N/A
N/A	Landing X Slope (%)	N/A	N/A	DWS Full Width?	N/A
N/A	Landing Curb? (Y/N)	N/A	N/A	DWS Offset (in)	N/A
N/A	Shared Landing?	N/A			
N/A	Gutter Ponding?	N/A	N/A	Gutter Slope (%)	N/A
N/A	Gutter Lip Ht (in)	N/A	N/A	Gutter X Slope (%)	N/A
N/A	Painted X Walk1?	No	N/A	Painted X Walk2?	N/A
	X Walk 1 Direction	To SW		X Walk 2 Direction	N/A
N/A	X Walk 1 Width (in)	N/A	N/A	X Walk 2 Width (in)	N/A
	X Walk 1 Slope (%)	2.6		X Walk 2 Slope (%)	N/A
	X Walk 1 X Slope (%)	5.3		X Walk 2 X Slope (%)	N/A

**Remove & Replace Entire Ramp.**
