# Access Compliance Report

## Public Rights-of-Way

### (Curb Ramps)

Intersection ID: 14147	Main Street: CHERRY_ST	Cross Street: LUTHER_ST	Location: W
ADA ID: 5DF304AC1D53	Ramp Type: Perpendicular Diagonal	Initial Pass/Fail: Fail	Overall Compliance: No
			Severity Score: 18.75

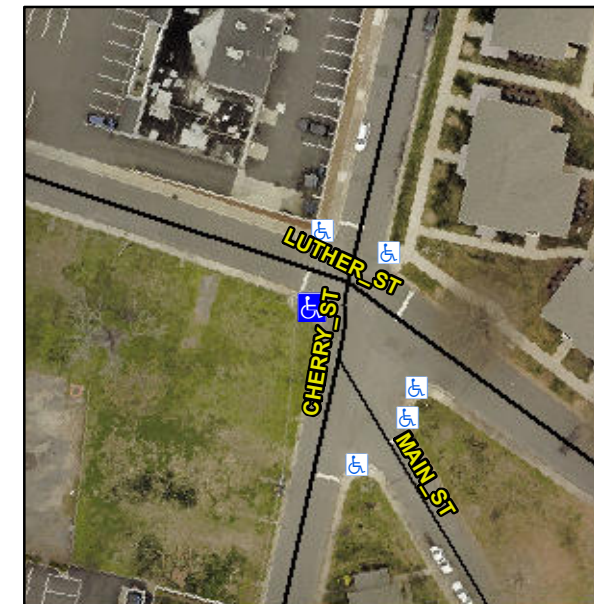
Compliance	Description	Data	Compliance	Description	Data
N/A	Ramp Length (in)	46.0	Yes	Ramp Slope (%)	5.1
No	Ramp Width (in)	32.0	No	Ramp XSlope (%)	2.5
N/A	Flare Type LT	N/A	N/A	Flare Type RT	N/A
N/A	Flare Slope LT (%)	N/A	N/A	Flare Slope RT (%)	N/A
N/A	Flare Traversable LT?	N/A	N/A	Flare Traversable RT?	N/A
N/A	Landing Length (in)	N/A	N/A	DWS Provided?	N/A
N/A	Landing Width (in)	N/A	N/A	DWS Contrast?	N/A
N/A	Landing Slope (%)	N/A	N/A	DWS Length (in)	N/A
N/A	Landing X Slope (%)	N/A	N/A	DWS Full Width?	N/A
N/A	Landing Curb? (Y/N)	N/A	N/A	DWS Offset (in)	N/A
N/A	Shared Landing?	N/A			
N/A	Gutter Ponding?	N/A	N/A	Gutter Slope (%)	N/A
N/A	Gutter Lip Ht (in)	N/A	N/A	Gutter X Slope (%)	N/A
N/A	Painted X Walk1?	No	N/A	Painted X Walk2?	No
	X Walk 1 Direction	To SE		X Walk 2 Direction	To NE
N/A	X Walk 1 Width (in)	N/A	N/A	X Walk 2 Width (in)	N/A
	X Walk 1 Slope (%)	0.6		X Walk 2 Slope (%)	1.6
	X Walk 1 X Slope (%)	3.2		X Walk 2 X Slope (%)	6.2

N/A	Ramp inside XWalk1?	N/A	N/A	Ramp inside XWalk2?	N/A
	Road Slope (%)	1.5	N/A	Clear Space?	N/A
	Road X Slope (%)	4.4	N/A	Clear Space to XWalk (in)	N/A
N/A	Any Obstructions?	N/A	N/A	Storm Grate/Utility Hazard?	N/A
	Obstruction Type			Storm Grate/Utility Type	
		N/A			N/A
			Yes	Surface Condition? (G/P)	Good

**Remove & Replace Curb Ramp With Two New Directional Ramps or Equivalent.**

**R304.5.1, R304.5.3**
