Access Compliance Report

Public Rights-of-Way

(Curb Ramps)

Intersection ID: 16126	Main Street: E_W_T_HARRIS_BV	Cross Street: IDLEWILD_RD	Location: NE
ADA ID: 5E00A5077FC6	Ramp Type: Perp	Initial Pass/Fail: Fail	Overall Compliance: No
Codes/Mitigation Info/Possible Solution		Field Measurements/Component Compliance	
Severity Score: 33.75

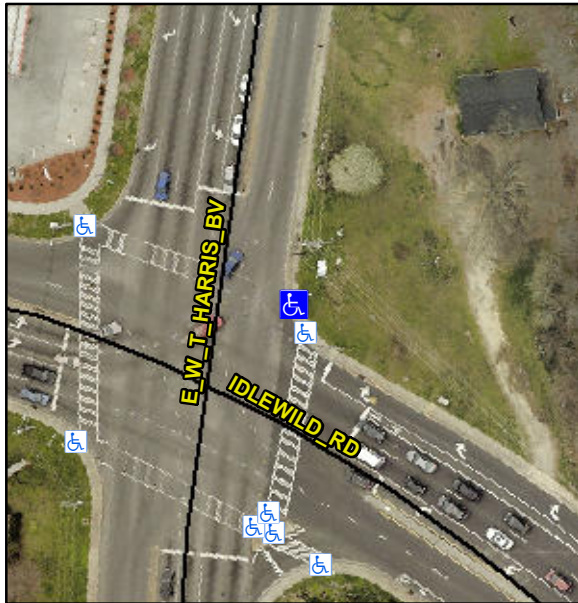
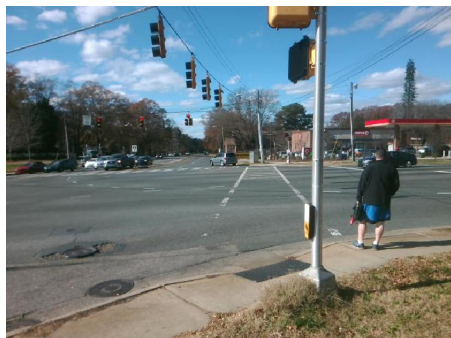
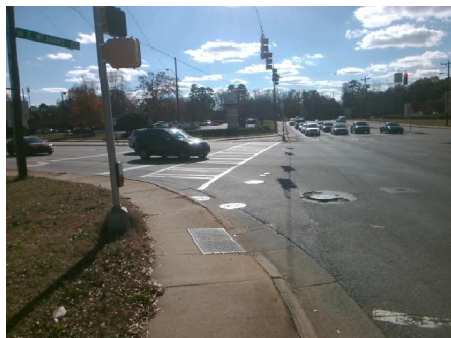
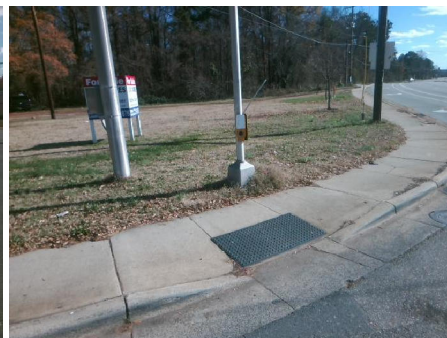
Compliance	Description	Data	Compliance	Description	Data
N/A	Ramp Length (in)	55.0	No	Ramp Slope (%)	13.9
No	Ramp Width (in)	40.0	Yes	Ramp XSlope (%)	0.9
N/A	Flare Type LT	N/A	N/A	Flare Type RT	N/A
N/A	Flare Slope LT (%)	N/A	N/A	Flare Slope RT (%)	N/A
N/A	Flare Traversable LT?	N/A	N/A	Flare Traversable RT?	N/A
N/A	Landing Length (in)	N/A	N/A	DWS Provided?	N/A
N/A	Landing Width (in)	N/A	N/A	DWS Contrast?	N/A
N/A	Landing Slope (%)	N/A	N/A	DWS Length (in)	N/A
N/A	Landing X Slope (%)	N/A	N/A	DWS Full Width?	N/A
N/A	Landing Curb? (Y/N)	N/A	N/A	DWS Offset (in)	N/A
N/A	Shared Landing?	N/A			
N/A	Gutter Ponding?	N/A	N/A	Gutter Slope (%)	N/A
N/A	Gutter Lip Ht (in)	N/A	N/A	Gutter X Slope (%)	N/A
N/A	Painted X Walk1?	No	N/A	Painted X Walk2?	N/A
	X Walk 1 Direction	To NW		X Walk 2 Direction	N/A
N/A	X Walk 1 Width (in)	N/A	N/A	X Walk 2 Width (in)	N/A
	X Walk 1 Slope (%)	2.1		X Walk 2 Slope (%)	N/A
	X Walk 1 X Slope (%)	2.7		X Walk 2 X Slope (%)	N/A

N/A	Ramp inside XWalk1?	N/A	N/A	Ramp inside XWalk2?	N/A
	Road Slope (%)	N/A	N/A	Clear Space?	N/A
	Road X Slope (%)	N/A	N/A	Clear Space to XWalk (in)	N/A
N/A	Any Obstructions?	N/A	N/A	Storm Grate/Utility Hazard?	N/A
	Obstruction Type			Storm Grate/Utility Type	
		N/A			N/A
			Yes	Surface Condition? (G/P)	Good

Possible Solutions:

Remove & Replace Entire Ramp.

R304.5.1, R304.2.2
