## Access Compliance Report Public Rights-of-Way (Curb Ramps)

Intersection ID: 14006 Main Street: ELIZABETH\_AV Cross Street: HAWTHORNE\_LN Location: S

ADA ID: 5E011326A6F3 Ramp Type: Perpendicular Diagonal Initial Pass/Fail: Fail Overall Compliance: No Severity Score: 58.75

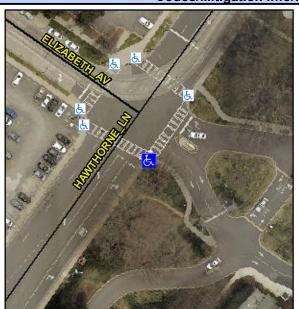
Not Found, R304.5.1, R304.2.2, R304.5.3

Compl			Data Compliance Description		Dete
	iance Description	Data			Data
N/A	Ramp Length (in)	53.0	No	Ramp Slope (%)	13.9
No	Ramp Width (in)	38.0	No	Ramp XSlope (%)	12.8
N/A	Flare Type LT	N/A	N/A	Flare Type RT	N/A
N/A	Flare Slope LT (%)	N/A	N/A	Flare Slope RT (%)	N/A
N/A	Flare Traversable LT?	N/A	N/A	Flare Traversable RT?	N/A
N/A	Landing Length (in)	N/A	N/A	DWS Provided?	N/A
N/A	Landing Width (in)	N/A	N/A	DWS Contrast?	N/A
N/A	Landing Slope (%)	N/A	N/A	DWS Length (in)	N/A
N/A	Landing X Slope (%)	N/A	N/A	DWS Full Width?	N/A
N/A	Landing Curb? (Y/N)	N/A	N/A	DWS Offset (in)	N/A
N/A	Shared Landing?	N/A			
N/A	Gutter Ponding?	N/A	N/A	Gutter Slope (%)	N/A
N/A	Gutter Lip Ht (in)	N/A	N/A	Gutter X Slope (%)	N/A
N/A	Painted X Walk1?	Yes	N/A	Painted X Walk2?	Yes
	X Walk 1 Direction	To NE		X Walk 2 Direction	To NW
N/A	X Walk 1 Width (in)	111.0	N/A	X Walk 2 Width (in)	112.0
	X Walk 1 Slope (%)	3.5		X Walk 2 Slope (%)	3.8

X Walk 1 X Slope (%)	5.5		X Walk 2 X Slope (%)	6.2
N/A	Ramp inside XWalk1?	Yes	N/A	Ramp inside XWalk2?	Yes
	Road Slope (%)	8.0	N/A	Clear Space?	N/A
	Road X Slope (%)	2.8	N/A	Clear Space to XWalk (in)	N/A
N/A	Any Obstructions?	N/A	N/A	Storm Grate/Utility Hazard?	N/A
	Obstruction Type		l	Storm Grate/Utility Type	
		N/A			N/A

Remove & Replace Curb Ramp With Two New Directional Ramps or Equivalent.
