## Access Compliance Report Public Rights-of-Way (Curb Ramps)

•		-					
Intersection ID: 20074	Main Str	Main Street: KREFELD_DR		Cross Street: CAUSEWAY_DR				Location:	S
ADA ID: 5E0478540FFA	Ramp Ty	Ramp Type: PerpDiag		Initial Pass/Fail: Fail Overall Compliance: No			o Severity Score:	46.25	
Codes/Mitigation Info/Possible Solution				Field Measurements/Component Compliance					
	2	Possible Solutions:		Compliance Description			Data Compliance Description		Data
La contraction of the second s		Remove & Replace Curb Ramp	With	N/A	Ramp Length (in)	59.0	No	Ramp Slope (%)	9.0
		Two New Directional Ramps or		No	Ramp Width (in)	42.0	No	Ramp XSlope (%)	9.1
		Equivalent.		N/A	Flare Type LT	N/A	N/A	Flare Type RT	N/A
				N/A	Flare Slope LT (%)	N/A	N/A	Flare Slope RT (%)	N/A
475 6				N/A	Flare Traversable LT?	N/A	N/A	Flare Traversable RT?	N/A
E Allo				N/A	Landing Length (in)	N/A	N/A	DWS Provided?	N/A
5		Surveyor Notes:		N/A	Landing Width (in)	N/A	N/A	DWS Contrast?	N/A
		N/A		N/A	Landing Slope (%)	N/A	N/A	DWS Length (in)	N/A

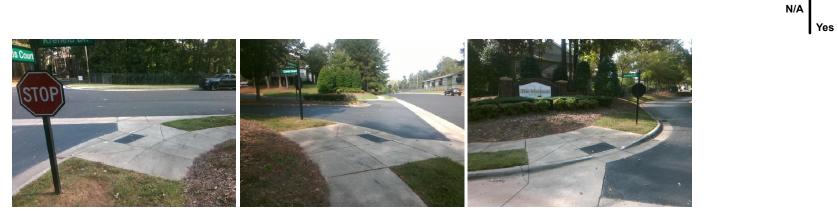
N/A	Landing X Slope (%)	N/A	N/A	DWS Full Width?	N/A
533				N/A	Landing Curb? (Y/N)	N/A	N/A	DWS Offset (in)	N/A
				N/A	Shared Landing?	N/A			
and the second		PROW/ADA:		N/A	Gutter Ponding?	N/A	N/A	Gutter Slope (%)	N/A
		Not Found, R304.5.1, R304.2.2		N/A	Gutter Lip Ht (in)	N/A	N/A	Gutter X Slope (%)	N/A
	1 1 1 1	R304.5.3		N/A	Painted X Walk1?	No	N/A	Painted X Walk2?	No
The Alex	n water and the				X Walk 1 Direction	To NE		X Walk 2 Direction	To NW
	March 1			N/A	X Walk 1 Width (in)	N/A	N/A	X Walk 2 Width (in)	N/A
Street 1 Name	KREFELD DR				X Walk 1 Slope (%)	6.5		X Walk 2 Slope (%)	3.7
Stop Condition-Street 2	None				X Walk 1 X Slope (%)	1.1		X Walk 2 X Slope (%)	5.7
Street 2 Name	CURTIS CT			N/A	Ramp inside XWalk1?	N/A	N/A	Ramp inside XWalk2?	N/A
Stop Condition-Street 1	StopSign				Road Slope (%)	7.4	N/A	Clear Space?	N/A
					Road X Slope (%)	1.9	N/A	Clear Space to XWalk (in)	N/A
				N/A	Any Obstructions?	N/A	N/A	Storm Grate/Utility Hazard?	N/A

s Surface Condition? (G/P) Good

Total Cost: \$	3200.00		Obstruction Type			Storm Grate/Utility Type	
						N/A			N/A
