Access Compliance Report

Public Rights-of-Way

(Curb Ramps)

Intersection ID: 3535	Main Street: CANTER_POST_DR	Cross Street: MT_HOLLY-HUNTERSVILLE_RD	Location: NW
ADA ID: 5E0E33E6EC8C	Ramp Type: Perpendicular	Initial Pass/Fail: Fail	Overall Compliance: No
Severity Score: 25			
Codes/Mitigation Info/Possible Solution		Field Measurements/Component Compliance

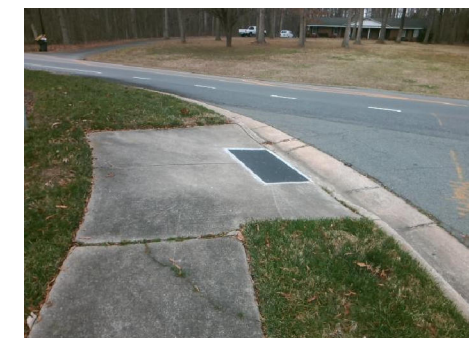
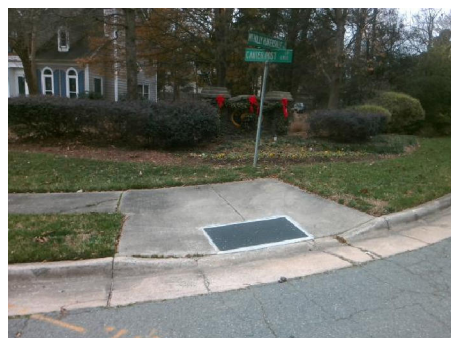
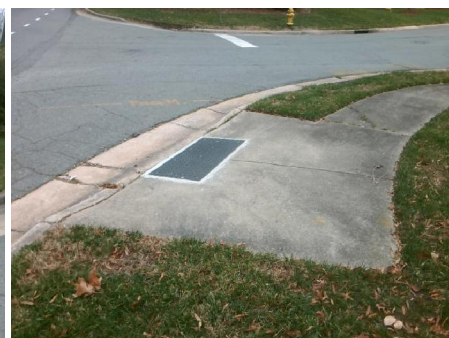
Not Found, R304.2.2, R304.5.3

Compliance	Description	Data	Compliance	Description	Data
N/A	Ramp Length (in)	47.0	No	Ramp Slope (%)	8.8
Yes	Ramp Width (in)	48.0	No	Ramp XSlope (%)	5.4
N/A	Flare Type LT	N/A	N/A	Flare Type RT	N/A
N/A	Flare Slope LT (%)	N/A	N/A	Flare Slope RT (%)	N/A
N/A	Flare Traversable LT?	N/A	N/A	Flare Traversable RT?	N/A
N/A	Landing Length (in)	N/A	N/A	DWS Provided?	N/A
N/A	Landing Width (in)	N/A	N/A	DWS Contrast?	N/A
N/A	Landing Slope (%)	N/A	N/A	DWS Length (in)	N/A
N/A	Landing X Slope (%)	N/A	N/A	DWS Full Width?	N/A
N/A	Landing Curb? (Y/N)	N/A	N/A	DWS Offset (in)	N/A
N/A	Shared Landing?	N/A			
N/A	Gutter Ponding?	N/A	N/A	Gutter Slope (%)	N/A
N/A	Gutter Lip Ht (in)	N/A	N/A	Gutter X Slope (%)	N/A
N/A	Painted X Walk1?	No	N/A	Painted X Walk2?	N/A
	X Walk 1 Direction	To N		X Walk 2 Direction	N/A
N/A	X Walk 1 Width (in)	N/A	N/A	X Walk 2 Width (in)	N/A
	X Walk 1 Slope (%)	3.5		X Walk 2 Slope (%)	N/A
	X Walk 1 X Slope (%)	4.7		X Walk 2 X Slope (%)	N/A

N/A	Ramp inside XWalk1?	N/A	N/A	Ramp inside XWalk2?	N/A
	Road Slope (%)	4.7	N/A	Clear Space?	N/A
	Road X Slope (%)	3.5	N/A	Clear Space to XWalk (in)	N/A
N/A	Any Obstructions?	N/A	N/A	Storm Grate/Utility Hazard?	N/A
	Obstruction Type			Storm Grate/Utility Type	
		N/A			N/A
			Yes	Surface Condition? (G/P)	Good

Possible Solutions:

Remove & Replace Entire Ramp.
