Access Compliance Report

Public Rights-of-Way

(Curb Ramps)

Intersection ID: 8552	Main Street: GARNETTE_PL	Cross Street: MITCHELL_ST	Location: SE
ADA ID: 5E110DA10B7E	Ramp Type: Combination1	Initial Pass/Fail: Fail	Overall Compliance: No
Severity Score: 58.75			
Codes/Mitigation Info/Possible Solution		Field Measurements/Component Compliance

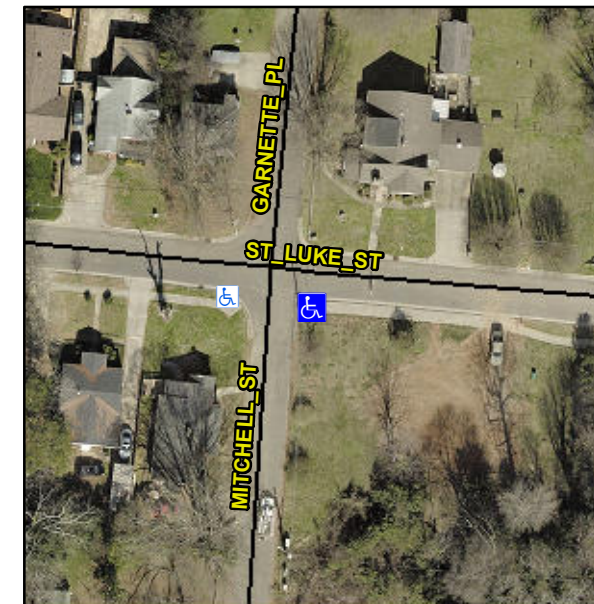
Not Found, R304.5.1, R304.5.3, R304.3.2

Compliance	Description	Data	Compliance	Description	Data
N/A	Ramp Length LT (in)	33.0	N/A	Ramp Length RT (in)	36.0
Yes	Ramp Width LT (in)	72.0	Yes	Ramp Width RT (in)	72.0
Yes	Ramp Slope LT (%)	5.8	No	Ramp Slope RT (%)	17.3
Yes	Ramp XSlope LT (%)	0.6	Yes	Ramp XSlope RT (%)	0.9
N/A	Ramp Length (in)	71.0	Yes	Ramp Slope (%)	1.9
No	Ramp Width (in)	46.5	No	Ramp XSlope (%)	9.5
N/A	Flare Type LT	N/A	N/A	Flare Type RT	N/A
N/A	Flare Slope LT (%)	N/A	N/A	Flare Slope RT (%)	N/A
N/A	Flare Traversable LT?	N/A	N/A	Flare Traversable RT?	N/A
N/A	Landing Length (in)	N/A	N/A	DWS Provided?	N/A
N/A	Landing Width (in)	N/A	N/A	DWS Contrast?	N/A
N/A	Landing Slope (%)	N/A	N/A	DWS Length (in)	N/A
N/A	Landing X Slope (%)	N/A	N/A	DWS Full Width?	N/A
N/A	Landing Curb? (Y/N)	N/A	N/A	DWS Offset (in)	N/A
N/A	Shared Landing?	N/A			
N/A	Gutter Ponding?	N/A	N/A	Gutter Slope (%)	N/A
N/A	Gutter Lip Ht (in)	N/A	N/A	Gutter X Slope (%)	N/A
N/A	Painted X Walk1?	No	N/A	Painted X Walk2?	N/A

X Walk 1 Direction	To W		X Walk 2 Direction	N/A
	X Walk 1 Width (in)	N/A		X Walk 2 Width (in)	N/A
	X Walk 1 Slope (%)	7.8		X Walk 2 Slope (%)	N/A
	X Walk 1 X Slope (%)	2.5		X Walk 2 X Slope (%)	N/A
N/A	Ramp inside XWalk1?	N/A	N/A	Ramp inside XWalk2?	N/A
	Road Slope (%)	N/A		Clear Space?	N/A
	Road X Slope (%)	N/A	N/A	Clear Space to XWalk (in)	N/A
			N/A	Any Obstruction?	N/A
				Obstruction Type	N/A
			N/A	Storm Grate/Utility Hazard?	N/A
				Storm Grate/Utility Type	N/A
			Yes	Surface Condition? (G/P)	Good
				Curb Slope (%)	11.5

Remove & Replace Entire Ramp.

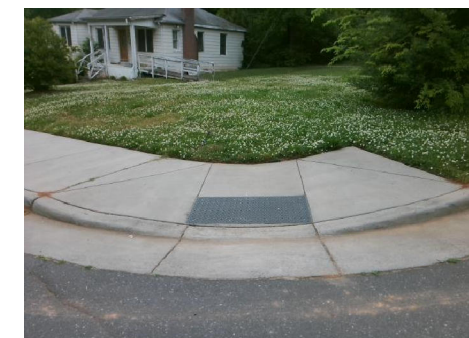
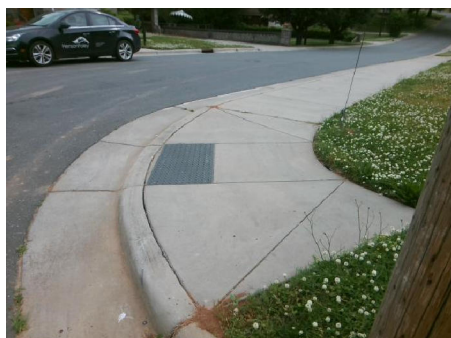
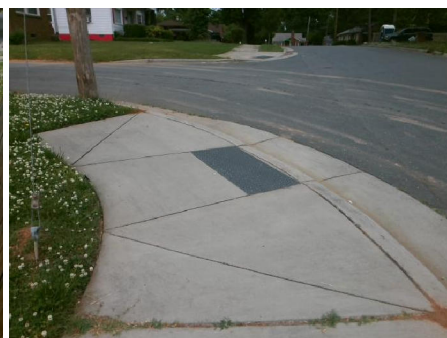
NO RT SW
