Access Compliance Report

Public Rights-of-Way

(Curb Ramps)

| Intersection ID: 29507 | Main Street: ROSS_MOORE_AV | Cross Street: SYLVIA_CT | Location: SE |

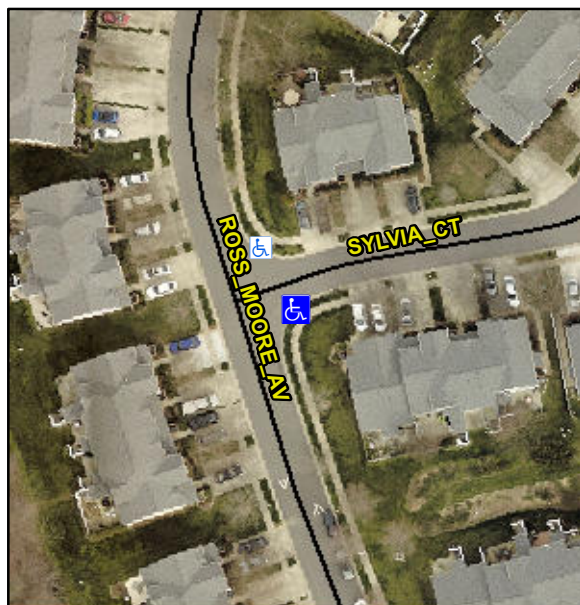
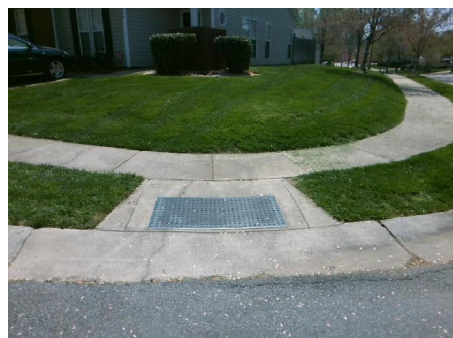
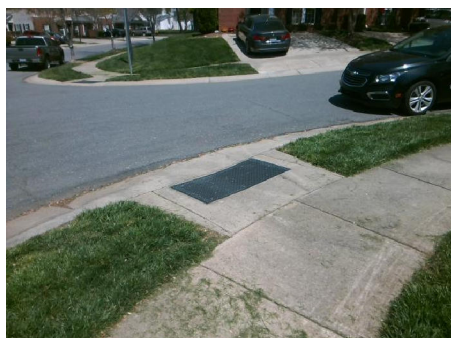
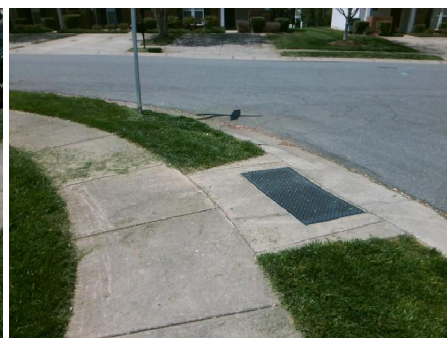
| ADA ID: 5E1454B51EDA | Ramp Type: PerpDiag | Initial Pass/Fail: Fail | Overall Compliance: No |
| Severity Score: 12.5 | | | |

Not Found, R304.5.3

| Compliance | Description | Data | Compliance | Description | Data |
|---|---|---|---|---|---|
| Yes | Ramp Width (in) | 48.0 | No | Ramp XSlope (%) | 5.1 |

Remove & Replace Curb Ramp With Two New Directional Ramps or Equivalent.
