# Access Compliance Report

## Public Rights-of-Way

### (Curb Ramps)

Intersection ID: 51721	Main Street: PROVIDENCE_RD_WEST	Cross Street: BALLANCROFT_PY	Location: NW
ADA ID: 5E18775A8B12	Ramp Type: BlendTrans1	Initial Pass/Fail: Fail	Overall Compliance: No
		Severity Score: 12.5

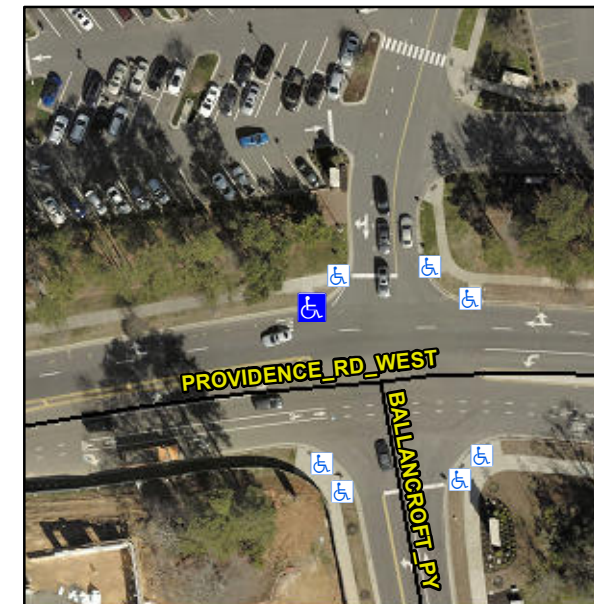
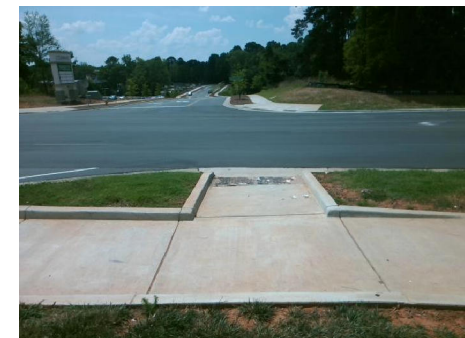
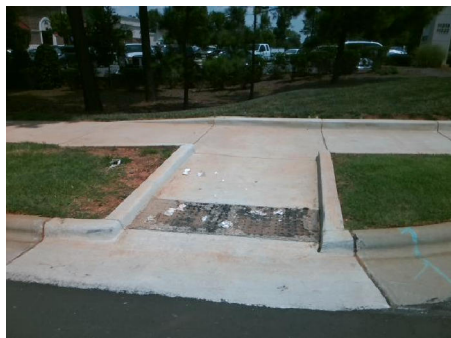
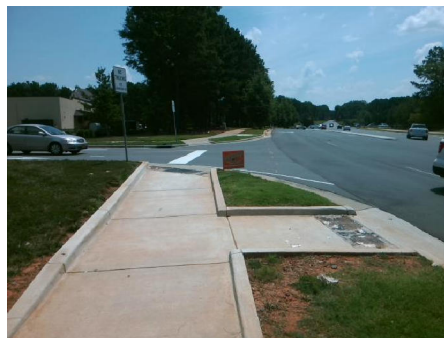
**Not Found, R304.5.3**

Compliance	Description	Data	Compliance	Description	Data
N/A	Ramp Length (in)	86.0	Yes	BlendTrans Slope (%)	4.5
Yes	Ramp Width (in)	71.0	No	BlendTrans XSlope (%)	6.5
N/A	Flare Type LT	N/A	N/A	Flare Type RT	N/A
N/A	Flare Slope LT (%)	N/A	N/A	Flare Slope RT (%)	N/A
N/A	Flare Traversable LT?	N/A	N/A	Flare Traversable RT?	N/A
N/A	Landing Length (in)	N/A	N/A	DWS Provided?	N/A
N/A	Landing Width (in)	N/A	N/A	DWS Contrast?	N/A
N/A	Landing Slope (%)	N/A	N/A	DWS Length (in)	N/A
N/A	Landing X Slope (%)	N/A	N/A	DWS Full Width?	N/A
N/A	Landing Curb? (Y/N)	N/A	N/A	DWS Offset (in)	N/A
N/A	Shared Landing?	N/A			
N/A	Gutter Ponding?	N/A	N/A	Gutter Slope (%)	N/A
N/A	Gutter Lip Ht (in)	N/A	N/A	Gutter X Slope (%)	N/A
N/A	Painted X Walk1?	No	N/A	Painted X Walk2?	N/A
	X Walk 1 Direction	To S		X Walk 2 Direction	N/A
	X Walk 1 Width (in)	N/A		X Walk 2 Width (in)	N/A
	X Walk 1 Slope (%)	4.2		X Walk 2 Slope (%)	N/A
	X Walk 1 X Slope (%)	4.1		X Walk 2 X Slope (%)	N/A

N/A	Ramp inside XWalk1?	N/A	N/A	Ramp inside XWalk2?	N/A
	Road Slope (%)	4.1		Clear Space?	N/A
	Road X Slope (%)	4.2	N/A	Clear Space to XWalk (in)	N/A
N/A	Any Obstructions?	N/A	N/A	Storm Grate/Utility Hazard?	N/A
	Obstruction Type			Storm Grate/Utility Type	
		N/A			N/A
			Yes	Surface Condition? (G/P)	Good
			No	Curb Slope (%)	5.7

**Remove & Replace Curb Ramp With Two New Directional Ramps or Equivalent.**
