Access Compliance Report

Public Rights-of-Way

(Curb Ramps)

| Intersection ID: 8029 | Main Street: FREEDOM_DR | Cross Street: TEDDINGTON_DR | Location: | E |

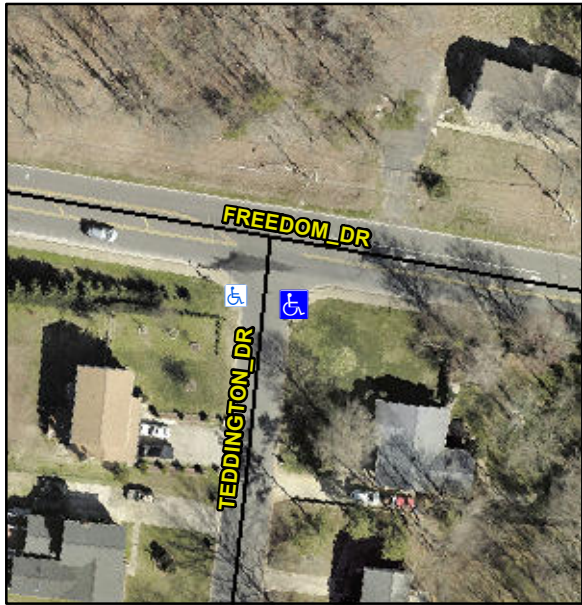
| ADA ID: 5E1E91DE1AB5 | Ramp Type: Perp | Initial Pass/Fail: Fail | Overall Compliance: No | Severity Score: 33.75 |

| Codes/Mitigation Info/Possible Solution | | | Field Measurements/Component Compliance | | | | | |
|--|---|---|---|---|---|---|---|---|
| | Remove & Replace Entire Ramp. | | N/A | Ramp Length (in) | 59.5 | No | Ramp Slope (%) | 13.5 |
| | | | No | Ramp Width (in) | 40.0 | Yes | Ramp XSlope (%) | 1.8 |
| PROW/ADA: | | R304.5.1, R304.2.2 | N/A | Shared Landing? | N/A | | | |

| Codes/Mitigation Info/Possible Solution | | | Field Measurements/Component Compliance | | | | | |
|--|---|---|---|---|---|---|---|---|
| | Possible Solutions: | | Compliance | Description | Data | Compliance | Description | Data |
