Access Compliance Report

Public Rights-of-Way (Curb Ramps)

Intersection ID: 10036289	Main Street: ROSE RIDGE PL	Cross Street: N/A	Location: NE
ADA ID: 5E2189144827	Ramp Type: Perp	Initial Pass/Fail: Fail	Overall Compliance: No Severity Score: 26.25

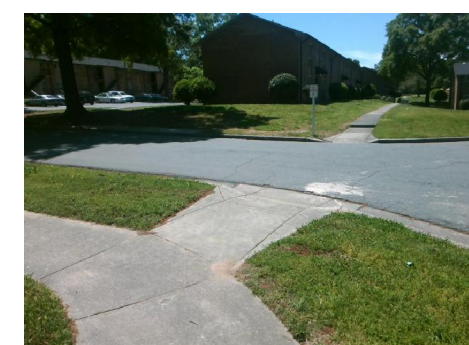
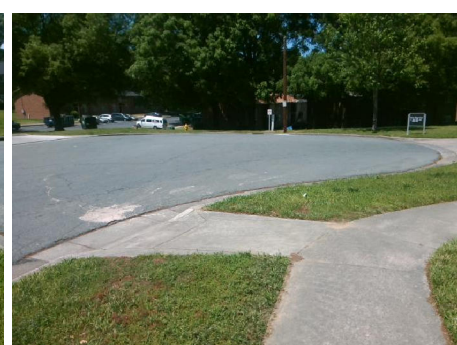
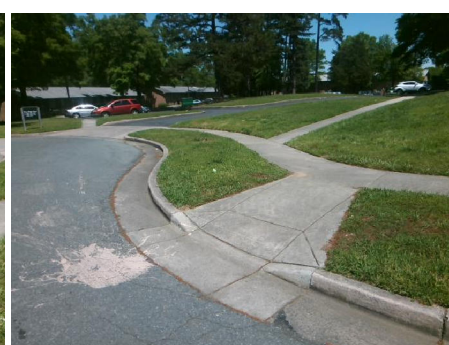
Possible Solutions:		Compliance	Description	Data
	Remove & Replace Entire Ramp.		No	Ramp Length (in)	93.0
			Yes	Ramp Width (in)	48.0
			N/A	Flare Type LT	N/A
			N/A	Flare Slope LT (%)	N/A
			N/A	Flare Traversable LT?	N/A
			N/A	Landing Length (in)	N/A
			N/A	Landing Width (in)	N/A
			N/A	Landing Slope (%)	N/A
			N/A	Landing X Slope (%)	N/A
<p>Surveyor Notes:</p> <p>N/A</p> <p>PROW/ADA:</p> <p>Not Found, R304.2.2, R304.5.3</p>			N/A	Flare Type RT	N/A
			N/A	Flare Slope RT (%)	N/A
			N/A	Flare Traversable RT?	N/A
			N/A	DWS Provided?	N/A
			N/A	DWS Contrast?	N/A
			N/A	DWS Length (in)	N/A
			N/A	DWS Full Width?	N/A
			N/A	DWS Offset (in)	N/A
			N/A	Gutter Ponding?	N/A
			N/A	Gutter Lip Ht (in)	N/A
			No	Painted X Walk1?	N/A
				X Walk 1 Direction	To SW
			N/A	X Walk 1 Width (in)	N/A
				X Walk 1 Slope (%)	3.6
				X Walk 1 X Slope (%)	3.2

N/A	Ramp inside XWalk1?	N/A
			N/A	Road Slope (%)	N/A
			N/A	Road X Slope (%)	N/A
			N/A	Any Obstructions?	N/A
				Obstruction Type	
Total Cost:					\$ 1850.00
			N/A		N/A
			Yes	Surface Condition? (G/P)	Good
