Access Compliance Report

Public Rights-of-Way

(Curb Ramps)

Intersection ID: 26468	Main Street: BEVINGTON_PL	Cross Street: REA_RD	Location: SW
ADA ID: 5E28F787BDB2	Ramp Type: Perp	Initial Pass/Fail: Fail	Overall Compliance: No
Severity Score: 21.25			
Codes/Mitigation Info/Possible Solution		Field Measurements/Component Compliance

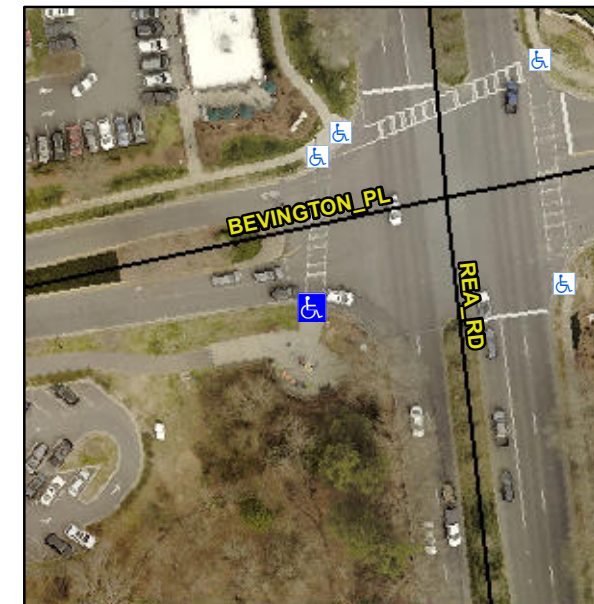
R304.5.1, R304.2.2

Compliance	Description	Data	Compliance	Description	Data
N/A	Ramp Length (in)	64.0	No	Ramp Slope (%)	8.7
No	Ramp Width (in)	41.0	Yes	Ramp XSlope (%)	1.1
N/A	Flare Type LT	N/A	N/A	Flare Type RT	N/A
N/A	Flare Slope LT (%)	N/A	N/A	Flare Slope RT (%)	N/A
N/A	Flare Traversable LT?	N/A	N/A	Flare Traversable RT?	N/A
N/A	Landing Length (in)	N/A	N/A	DWS Provided?	N/A
N/A	Landing Width (in)	N/A	N/A	DWS Contrast?	N/A
N/A	Landing Slope (%)	N/A	N/A	DWS Length (in)	N/A
N/A	Landing X Slope (%)	N/A	N/A	DWS Full Width?	N/A
N/A	Landing Curb? (Y/N)	N/A	N/A	DWS Offset (in)	N/A
N/A	Shared Landing?	N/A			
N/A	Gutter Ponding?	N/A	N/A	Gutter Slope (%)	N/A
N/A	Gutter Lip Ht (in)	N/A	N/A	Gutter X Slope (%)	N/A
N/A	Painted X Walk1?	Yes	N/A	Painted X Walk2?	N/A
	X Walk 1 Direction	To NE		X Walk 2 Direction	N/A
N/A	X Walk 1 Width (in)	122.5	N/A	X Walk 2 Width (in)	N/A
	X Walk 1 Slope (%)	9.5		X Walk 2 Slope (%)	N/A
	X Walk 1 X Slope (%)	0.5		X Walk 2 X Slope (%)	N/A

N/A	Ramp inside XWalk1?	Yes	N/A	Ramp inside XWalk2?	N/A
	Road Slope (%)	N/A	N/A	Clear Space?	N/A
	Road X Slope (%)	N/A	N/A	Clear Space to XWalk (in)	N/A
N/A	Any Obstructions?	N/A	N/A	Storm Grate/Utility Hazard?	N/A
	Obstruction Type			Storm Grate/Utility Type	
		N/A			N/A
		Yes		Surface Condition? (G/P)	Good

Possible Solutions:

Remove & Replace Entire Ramp.

Total Cost: \$ 1850.00
