# Access Compliance Report

## Public Rights-of-Way

### (Curb Ramps)

Intersection ID: 3285	Main Street: MALLARD_CREEK_RD	Cross Street: JOHNSTON_OEHLER_RD	Location: N
ADA ID: 5E2AD06806C6	Ramp Type: Para	Initial Pass/Fail: Fail	Overall Compliance: No
Codes/Mitigation Info/Possible Solution		Field Measurements/Component Compliance	
Severity Score: 26.25

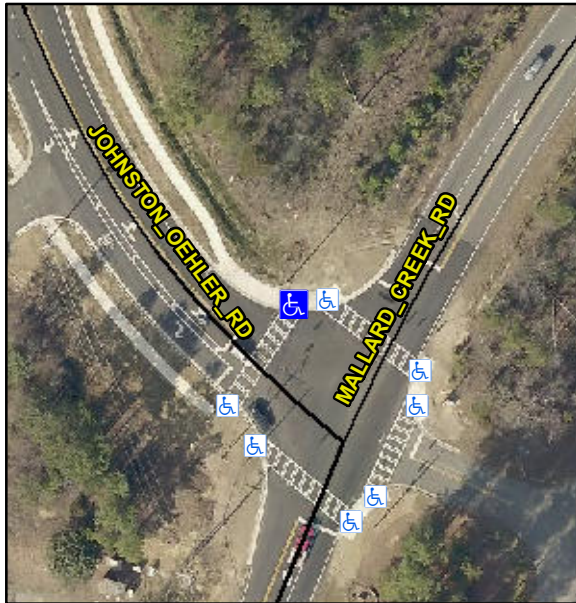
**RT RP < 5%**

**R304.3.2, R304.5.3**

Compliance	Description	Data	Compliance	Description	Data
N/A	Ramp Length LT (in)	60.0	N/A	Ramp Length RT (in)	62.0
Yes	Ramp Width LT (in)	96.0	Yes	Ramp Width RT (in)	96.0
No	Ramp Slope LT (%)	13.8	Yes	Ramp Slope RT (%)	4.0
No	Ramp XSlope LT (%)	3.6	Yes	Ramp XSlope RT (%)	0.7
N/A	Landing Length (in)	N/A	N/A	DWS Provided?	N/A
N/A	Landing Width (in)	N/A	N/A	DWS Contrast?	N/A
N/A	Landing Slope (%)	N/A	N/A	DWS Length (in)	N/A
N/A	Landing X Slope (%)	N/A	N/A	DWS Full Width?	N/A
N/A	Landing Curb? (Y/N)	N/A	N/A	DWS Offset (in)	N/A
N/A	Shared Landing?	N/A			
N/A	Gutter Ponding?	N/A	N/A	Gutter Slope (%)	N/A
N/A	Gutter Lip Ht (in)	N/A	N/A	Gutter X Slope (%)	N/A
N/A	Painted X Walk1?	Yes	N/A	Painted X Walk2?	N/A
	X Walk 1 Direction	To SW		X Walk 2 Direction	N/A
N/A	X Walk 1 Width (in)	104.0	N/A	X Walk 2 Width (in)	N/A
	X Walk 1 Slope (%)	4.1		X Walk 2 Slope (%)	N/A
	X Walk 1 X Slope (%)	0.6		X Walk 2 X Slope (%)	N/A
N/A	Ramp inside XWalk1?	Yes	N/A	Ramp inside XWalk2?	N/A

Possible Solutions:

**Remove & Replace Entire Ramp.**

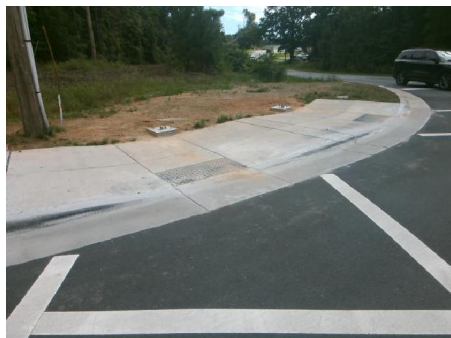
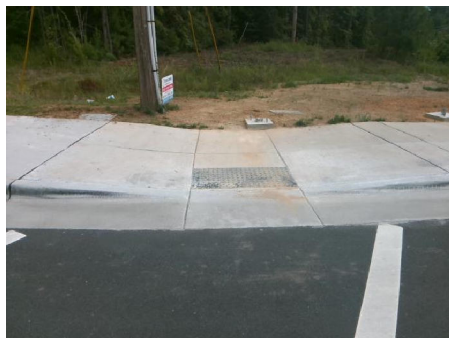
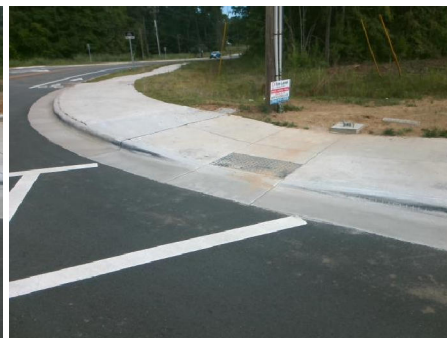
Road Slope (%)	N/A	N/A	Clear Space?	N/A
	Road X Slope (%)	N/A	N/A	Clear Space to XWalk (in)	N/A
N/A	Any Obstructions?	N/A	N/A	Storm Grate/Utility Hazard?	N/A
	Obstruction Type			Storm Grate/Utility Type	
		N/A			N/A
			Yes	Surface Condition? (G/P)	Good
			N/A	Curb Slope (%)	N/A
