Intersection ID: 5553	Main Street: HAWKINS_PL	Cross Street: ROCKWELL_BV	Location:	W
ADA ID: 5E2F8DB34684	Ramp Type: Para	Initial Pass/Fail: Fail	Overall Compliance: No	Severity Score: 12.5

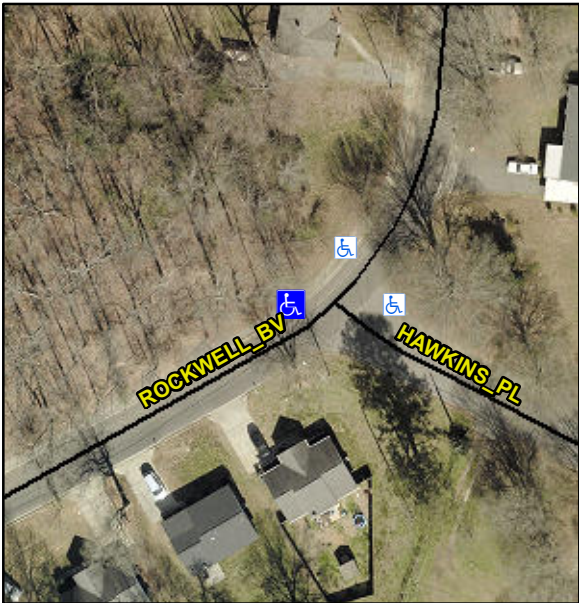
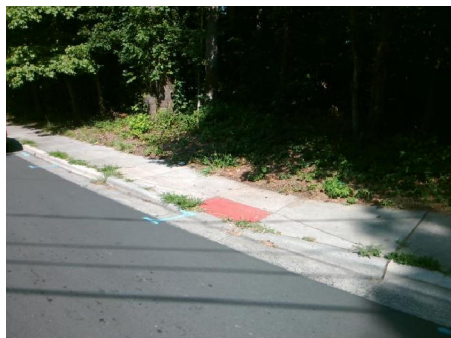
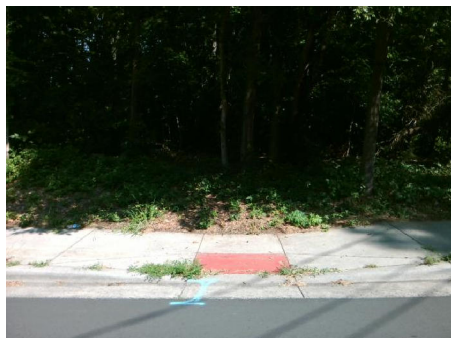
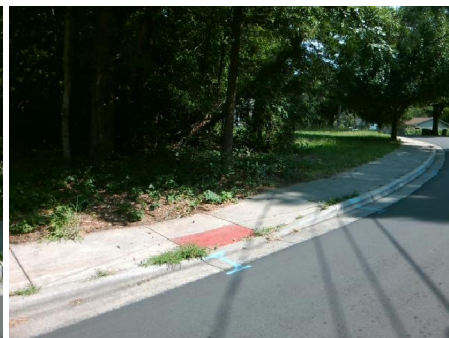
Possible Solutions:		Compliance	Description	Data	Compliance	Description	Data
	Remove & Replace Entire Ramp.		N/A	Ramp Length LT (in)	N/A	N/A	Ramp Length RT (in)	70.0
			N/A	Ramp Width LT (in)	N/A	No	Ramp Width RT (in)	35.0
			N/A	Ramp Slope LT (%)	N/A	No	Ramp Slope RT (%)	11.3
			N/A	Ramp XSlope LT (%)	N/A	Yes	Ramp XSlope RT (%)	0.6
			N/A	Landing Length (in)	N/A	N/A	DWS Provided?	N/A
			N/A	Landing Width (in)	N/A	N/A	DWS Contrast?	N/A
			N/A	Landing Slope (%)	N/A	N/A	DWS Length (in)	N/A
			N/A	Landing X Slope (%)	N/A	N/A	DWS Full Width?	N/A
			N/A	Landing Curb? (Y/N)	N/A	N/A	DWS Offset (in)	N/A
Surveyor Notes:			N/A	Shared Landing?	N/A			
N/A			N/A	Gutter Ponding?	N/A	N/A	Gutter Slope (%)	N/A
PROW/ADA:			N/A	Gutter Lip Ht (in)	N/A	N/A	Gutter X Slope (%)	N/A
R304.5.1, R304.3.2			N/A	Painted X Walk1?	No	N/A	Painted X Walk2?	N/A

X Walk 1 Direction	To E		X Walk 2 Direction	N/A
			N/A	X Walk 1 Width (in)	N/A	N/A	X Walk 2 Width (in)	N/A
				X Walk 1 Slope (%)	7.5		X Walk 2 Slope (%)	N/A
				X Walk 1 X Slope (%)	3.8		X Walk 2 X Slope (%)	N/A
			N/A	Ramp inside XWalk1?	N/A	N/A	Ramp inside XWalk2?	N/A
				Road Slope (%)	N/A	N/A	Clear Space?	N/A
				Road X Slope (%)	N/A	N/A	Clear Space to XWalk (in)	N/A
			N/A	Any Obstructions?	N/A	N/A	Storm Grate/Utility Hazard?	N/A
				Obstruction Type			Storm Grate/Utility Type	
Total Cost:		\$ 1600.00			N/A			N/A
						Yes	Surface Condition? (G/P)	Good
						N/A	Curb Slope (%)	13.1
