# Access Compliance Report

## Public Rights-of-Way

### (Curb Ramps)

Intersection ID: 32270	Main Street: SPRINGWELL_ST	Cross Street: LANCASTER_HY	Location: NW
ADA ID: 5E313FE017D8	Ramp Type: PerpDiag	Initial Pass/Fail: Fail	Overall Compliance: No
		Severity Score: 35

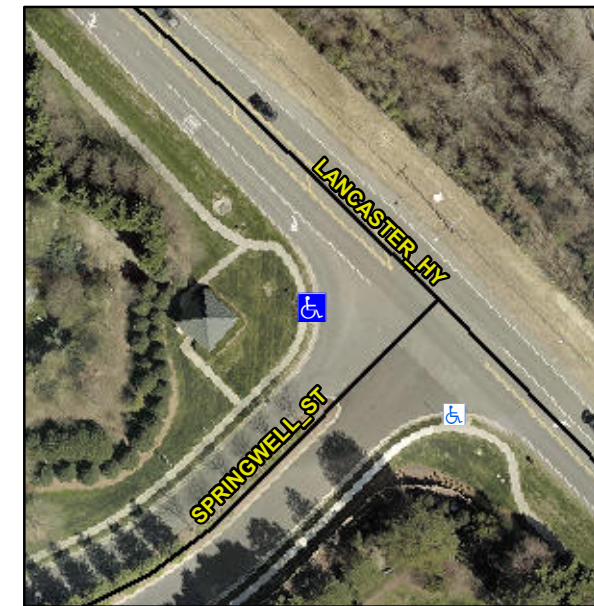
Compliance	Description	Data	Compliance	Description	Data
N/A	Ramp Length (in)	48.0	No	Ramp Slope (%)	14.5
No	Ramp Width (in)	43.5	No	Ramp XSlope (%)	4.1
N/A	Flare Type LT	N/A	N/A	Flare Type RT	N/A
N/A	Flare Slope LT (%)	N/A	N/A	Flare Slope RT (%)	N/A
N/A	Flare Traversable LT?	N/A	N/A	Flare Traversable RT?	N/A
N/A	Landing Length (in)	N/A	N/A	DWS Provided?	N/A
N/A	Landing Width (in)	N/A	N/A	DWS Contrast?	N/A
N/A	Landing Slope (%)	N/A	N/A	DWS Length (in)	N/A
N/A	Landing X Slope (%)	N/A	N/A	DWS Full Width?	N/A
N/A	Landing Curb? (Y/N)	N/A	N/A	DWS Offset (in)	N/A
N/A	Shared Landing?	N/A			
N/A	Gutter Ponding?	N/A	N/A	Gutter Slope (%)	N/A
N/A	Gutter Lip Ht (in)	N/A	N/A	Gutter X Slope (%)	N/A
N/A	Painted X Walk1?	No	N/A	Painted X Walk2?	No
	X Walk 1 Direction	To SE		X Walk 2 Direction	To NE
N/A	X Walk 1 Width (in)	N/A	N/A	X Walk 2 Width (in)	N/A
	X Walk 1 Slope (%)	1.0		X Walk 2 Slope (%)	4.3
	X Walk 1 X Slope (%)	3.9		X Walk 2 X Slope (%)	1.6

N/A	Ramp inside XWalk1?	N/A	N/A	Ramp inside XWalk2?	N/A
	Road Slope (%)	4.1	N/A	Clear Space?	N/A
	Road X Slope (%)	2.7	N/A	Clear Space to XWalk (in)	N/A
N/A	Any Obstructions?	N/A	N/A	Storm Grate/Utility Hazard?	N/A
	Obstruction Type			Storm Grate/Utility Type	
		N/A			N/A
			Yes	Surface Condition? (G/P)	Good

**Remove & Replace Curb Ramp With Two New Directional Ramps or Equivalent.**

**Not Found, R304.5.1, R304.2.2, R304.5.3**
