Access Compliance Report Public Rights-of-Way (Curb Ramps)

Intersection ID: N/A	Main Street: PINEVILLE-MATTHEWS_RD	Cross Street: KETTERING_DR	Location: NE
ADA ID: 5E39409AB587	Ramp Type: PerpDiag	Initial Pass/Fail: Fail	Overall Compliance: No Severity Score: 12.5

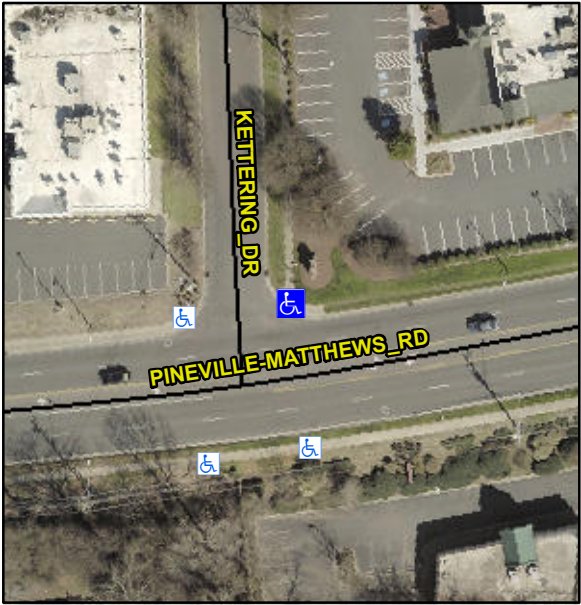
Compliance	Description	Data	Compliance	Description	Data
N/A	Ramp Length (in)	57.5	No	Ramp Slope (%)	9.8
Yes	Ramp Width (in)	48.0	Yes	Ramp XSlope (%)	1.1
N/A	Flare Type LT	N/A	N/A	Flare Type RT	N/A
N/A	Flare Slope LT (%)	N/A	N/A	Flare Slope RT (%)	N/A
N/A	Flare Traversable LT?	N/A	N/A	Flare Traversable RT?	N/A
N/A	Landing Length (in)	N/A	N/A	DWS Provided?	N/A
N/A	Landing Width (in)	N/A	N/A	DWS Contrast?	N/A
N/A	Landing Slope (%)	N/A	N/A	DWS Length (in)	N/A
N/A	Landing X Slope (%)	N/A	N/A	DWS Full Width?	N/A
N/A	Landing Curb? (Y/N)	N/A	N/A	DWS Offset (in)	N/A
N/A	Shared Landing?	N/A			
N/A	Gutter Ponding?	N/A	N/A	Gutter Slope (%)	N/A
N/A	Gutter Lip Ht (in)	N/A	N/A	Gutter X Slope (%)	N/A
N/A	Painted X Walk1?	No	N/A	Painted X Walk2?	No
	X Walk 1 Direction	To W		X Walk 2 Direction	To S
N/A	X Walk 1 Width (in)	N/A	N/A	X Walk 2 Width (in)	N/A
	X Walk 1 Slope (%)	3.5		X Walk 2 Slope (%)	1.1
	X Walk 1 X Slope (%)	0.6		X Walk 2 X Slope (%)	3.3

N/A	Ramp inside XWalk1?	N/A	N/A	Ramp inside XWalk2?	N/A
	Road Slope (%)	0.7	N/A	Clear Space?	N/A
	Road X Slope (%)	4.1	N/A	Clear Space to XWalk (in)	N/A
N/A	Any Obstructions?	N/A	N/A	Storm Grate/Utility Hazard?	N/A
	Obstruction Type			Storm Grate/Utility Type	
		N/A			N/A
			Yes	Surface Condition? (G/P)	Good

Possible Solutions:
Remove & Replace Curb Ramp With Two New Directional Ramps or Equivalent.

PROW/ADA:
R304.2.2
